# TransAlta Tri Leisure Centre

Prepared for: TransAlta Tri Leisure Centre

Nordic Mechanical Services Ltd.

# EXECUTIVE SUMMARY

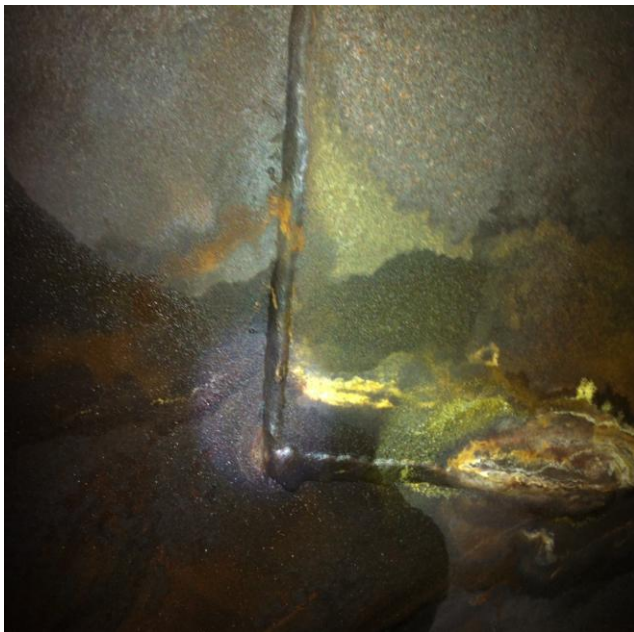
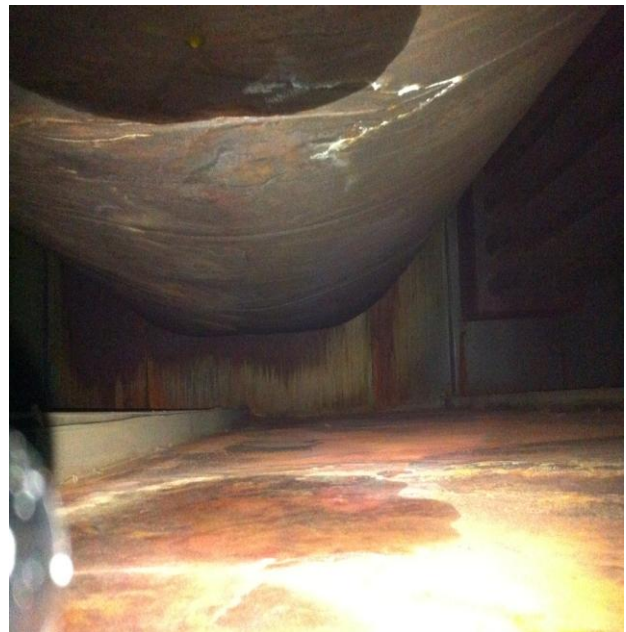
1. During the initial heating repair, numerous flame failures were noted and normal trouble shooting procedures were not successful. We determined that the heat exchanger needed to be inspected, as we suspected the pilot flame was being influenced by an outside source. Once the side panels were removed and access to the heat exchanger was gained, we found the source to our erratic flame

problem. We found numerous cracks and holes in the heat exchanger which was allowing the supply fan blower to blow discharge air into the heat exchanger causing the pilot flame to be moved off of the flame rod, causing the unit to trip.

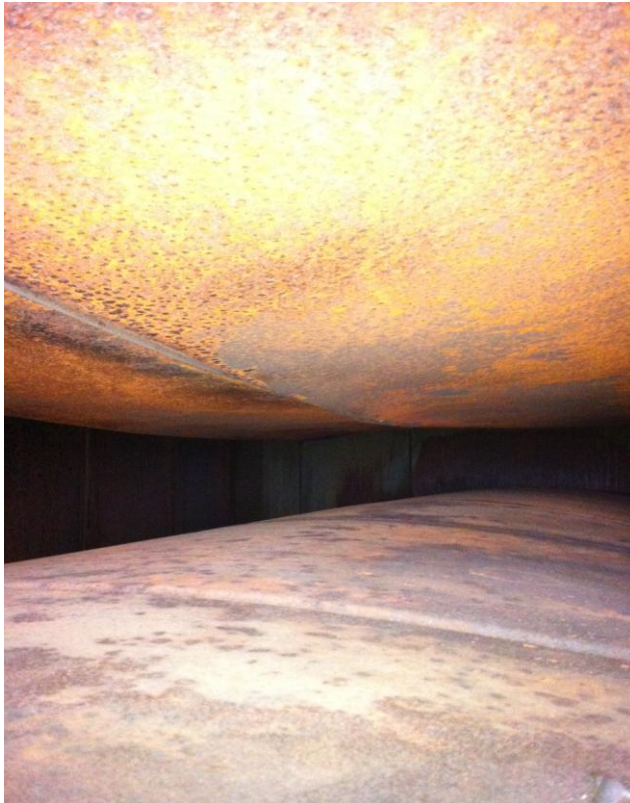
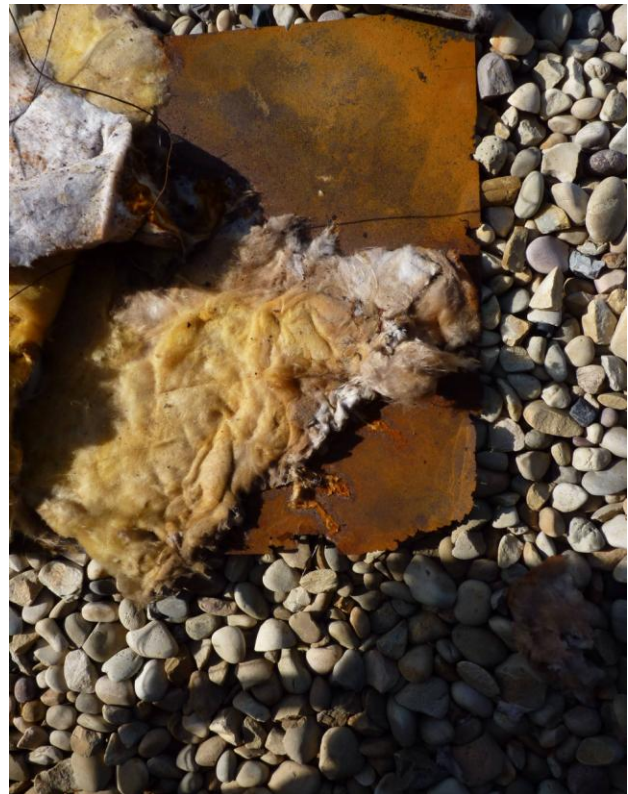
2. During our inspection of the heat exchanger section we found that the wall and ceiling panels which are essentially a structural component of the roof top unit were so badly corroded that the inside metal

liner collapsed and fell to the ground. Corrosion of the heating section is severe and requires all panels to be replaced. Basically rebuilding the heating section from the ground up. Given the state of other repairs required for this unit this option is not financially attractive.

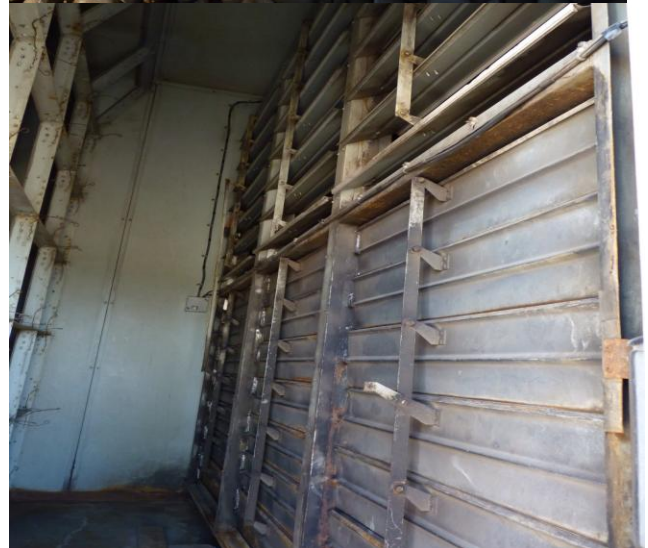
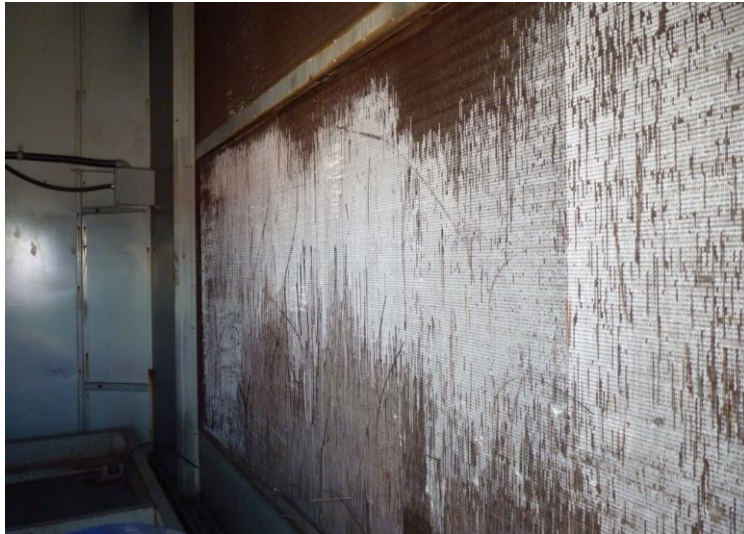
3. In addition to the heating section the mixed air damper section has dampers that are bent and rusted and are not providing a tight shut off, as result of frozen linkage and a defective damper

motors. In addition, moisture damage has aged these dampers beyond economical repairs.

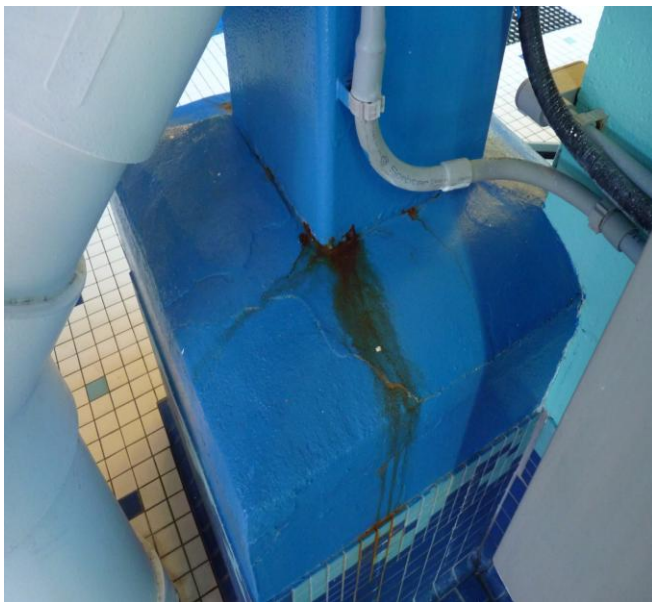
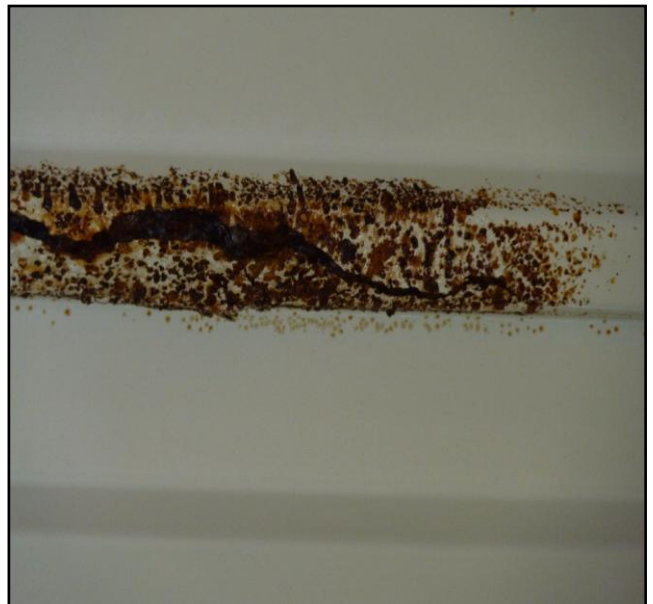
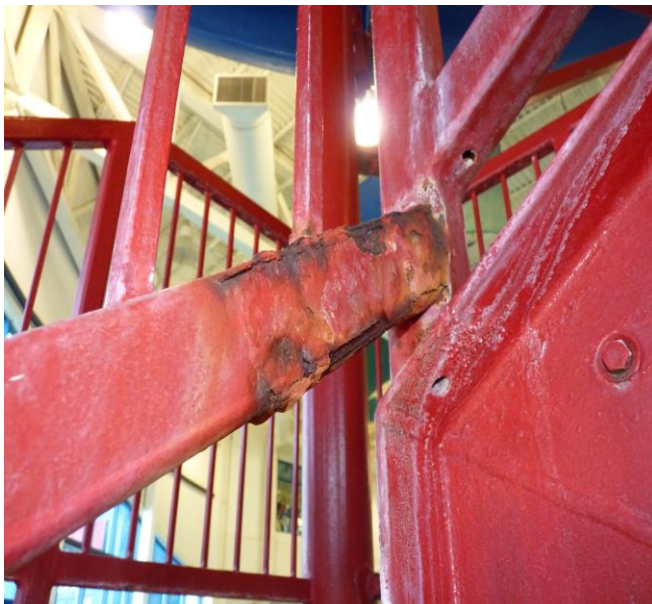
8. Building humidity levels have not been able to be kept within safe levels over the last 7 or 8 years due to the mechanical issues with the roof top unit, and have caused problems for the pool structure. High humidity levels have caused condensation to build up with in the steel support columns and they now shows signs of drainage at the base of these columns. Requires additional time to investigate.
9. The roof deck is rusted, and in one place has perforated the roof deck. Additional time is required to investigate the source of the leak, and determine if the leak is condensate or an actual roof leak. A Q deck patch is needed to be welded in place and painted with epoxy. A roofing contractor will need to be consulted for pricing.

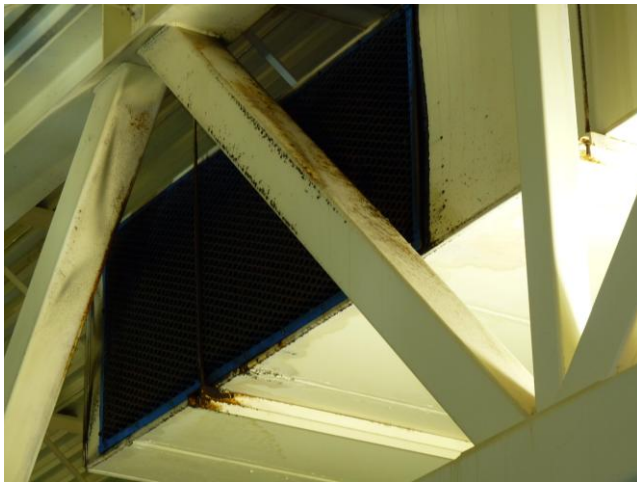
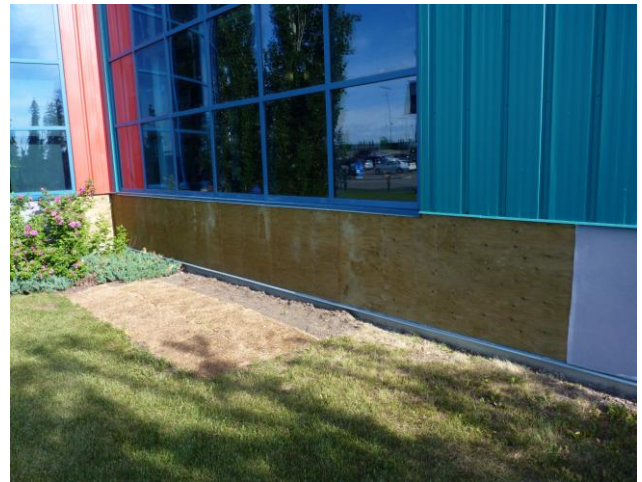
10. Paint on the roof deck and beams are discolored indicating corrosion is forming under the paint. A painting contractor should be consulted to look further into this issue.
