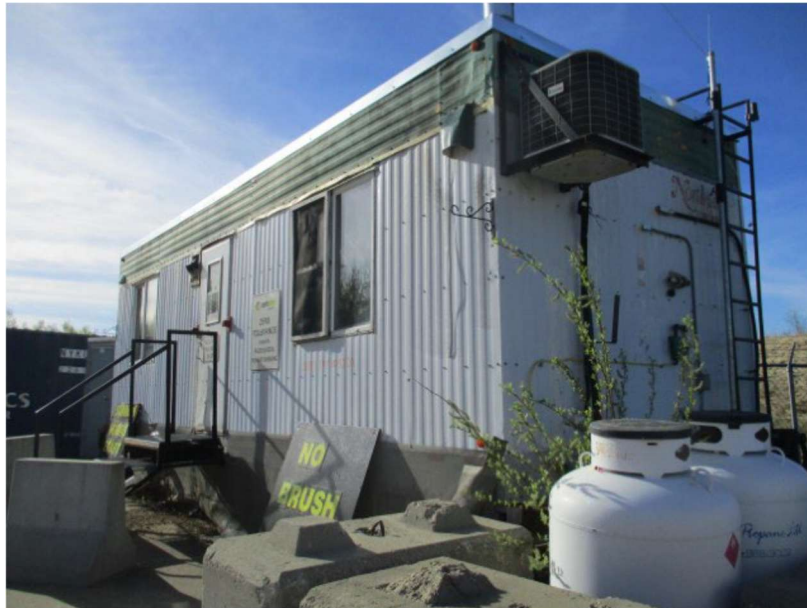
PICTURE 1 – SIDING IN DISREPAIR

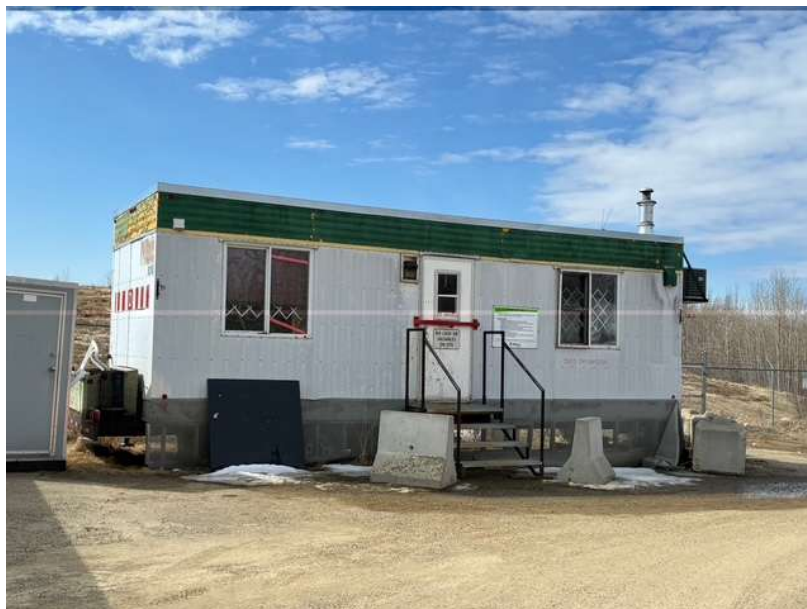
PICTURE 2 – MISSING SKIRTING

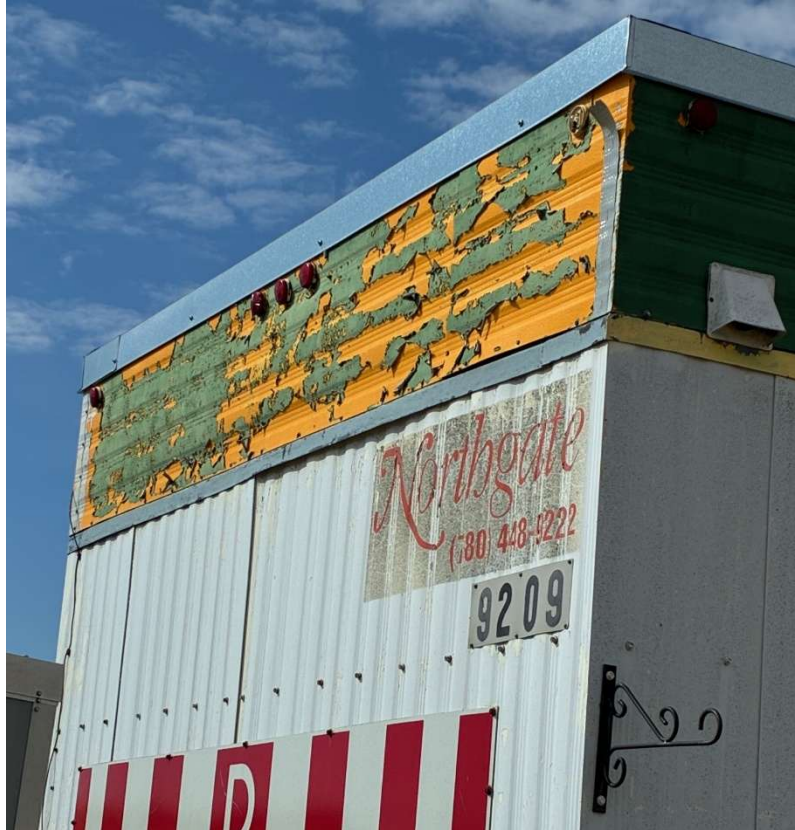
PICTURE 3 – SIDING IN DISREPAIR

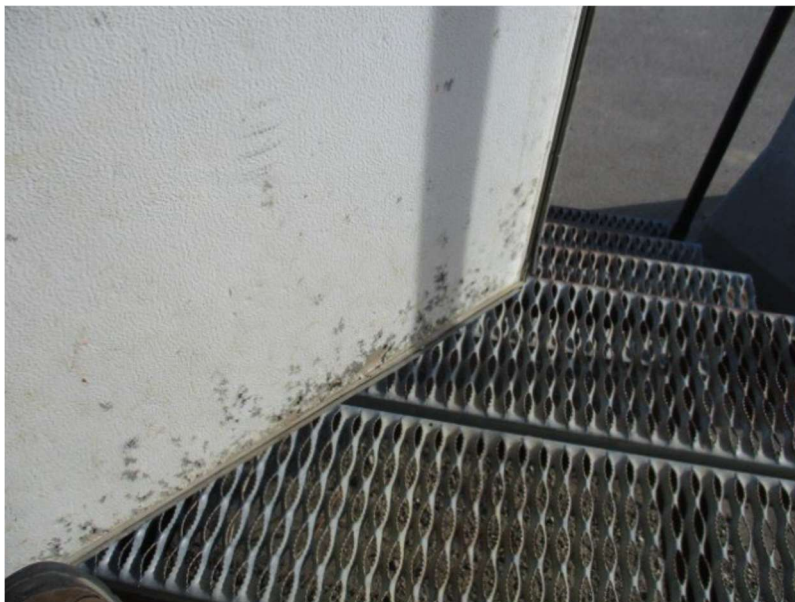
PICTURE 4 – DAMAGE TO DOORWAYS

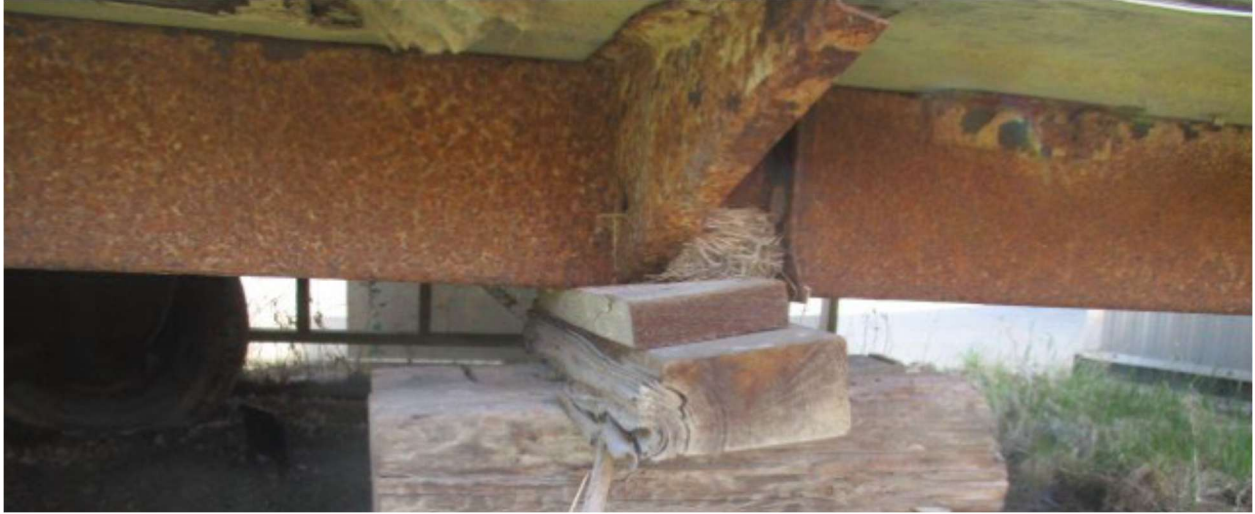
PICTURE 5 – SIGNIFICANT WEAR ON STRUCTURAL FRAME

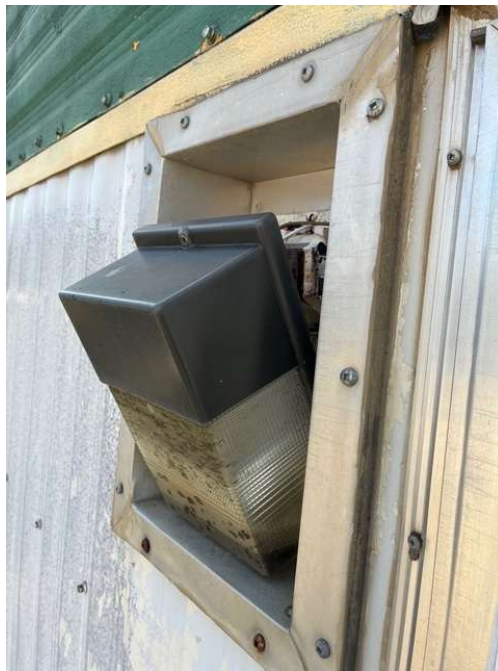
PICTURE 6 – LIGHTING SEPARATED FROM JUNCTION BOX

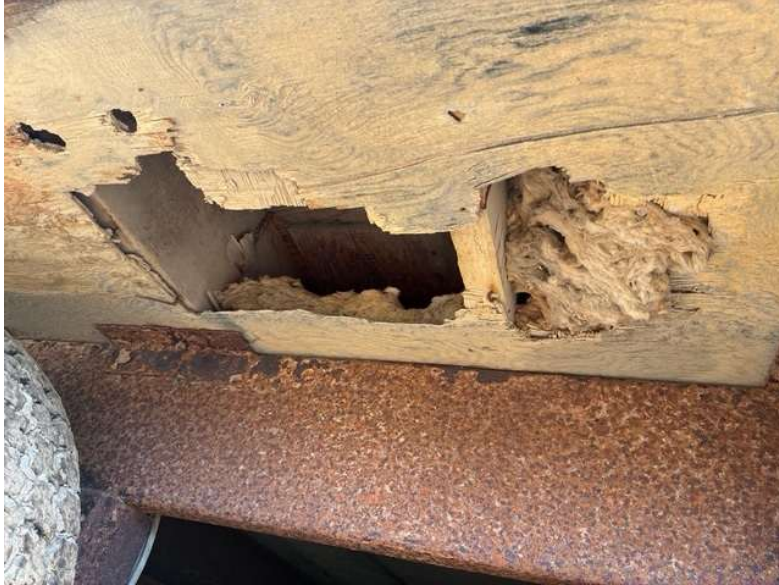
PICTURE 7 – HOLES IN SUBFLOOR, REMNANTS OF INFESTATION

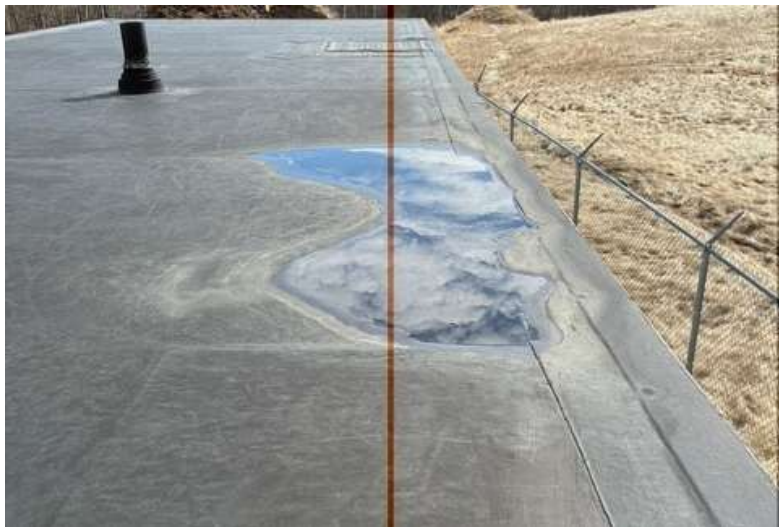
PICTURE 8 – STANDING WATER ON ROOF

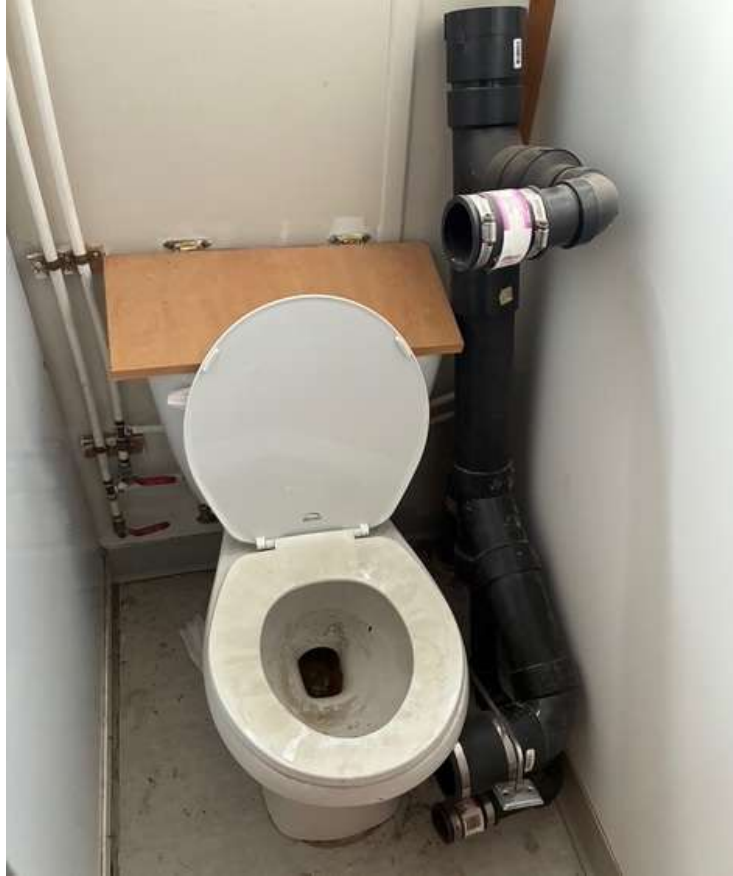
PICTURE 9 – PLUMBING OUT OF SERVICE

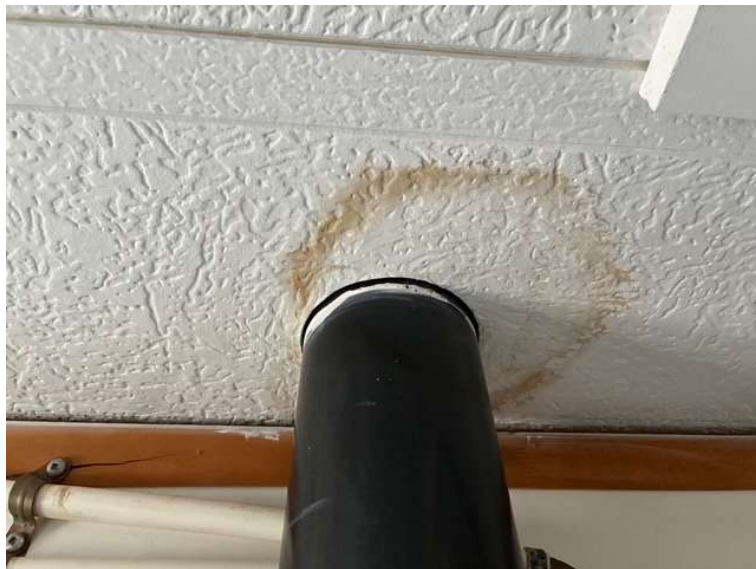
PICTURE 10 – SIGNS OF WATER DAMAGE IN CEILING

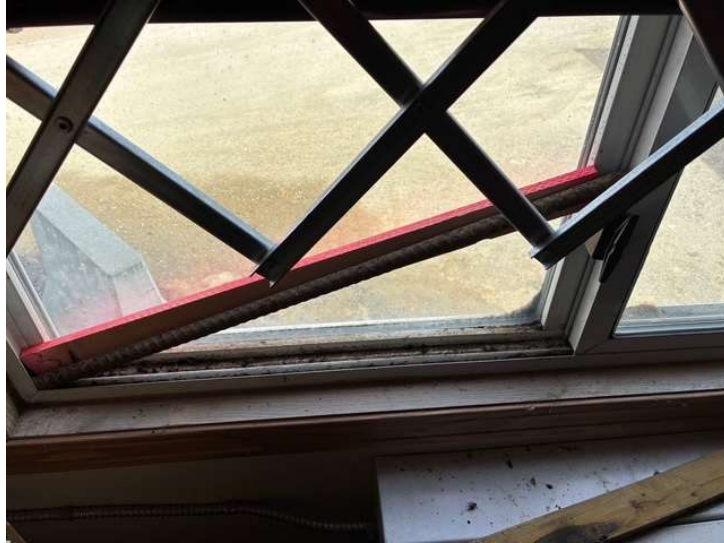
PICTURE 11 – INADEQUATE SECURITY MEASURES

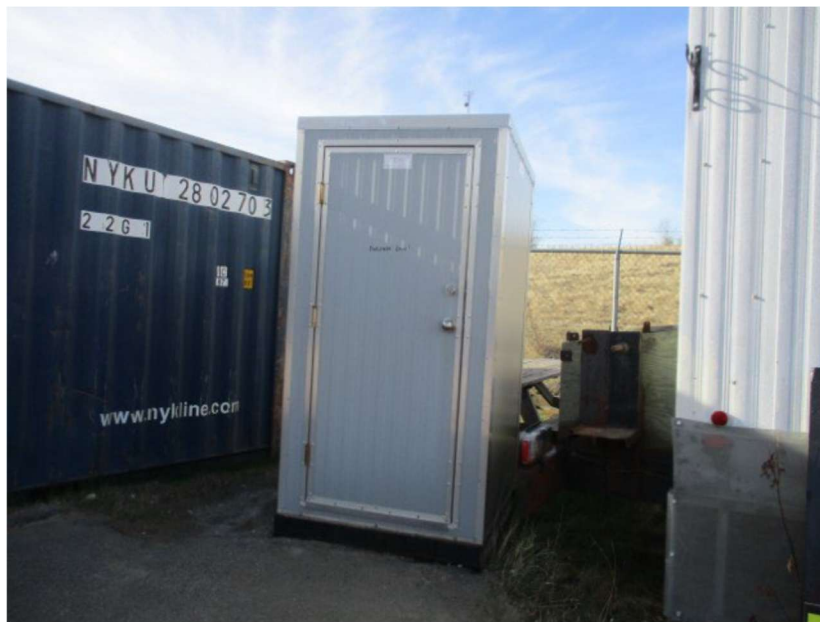
PICTURE 12 – ADDITIONAL OPERATIONAL COSTS TO SUPPORT HEATED PORT-A-POTTY
