**Community Association
Sustainability Fund - MAJOR
2014 Grant Application**

| Proposed Project: | Roof Repair & Interior Remediation |

Re: Entwistle Community Hall
4921 – 51 Street
Entwistle, Alberta
Lots 13,14,15 Block 6 Plan 7471V

Inspection Report

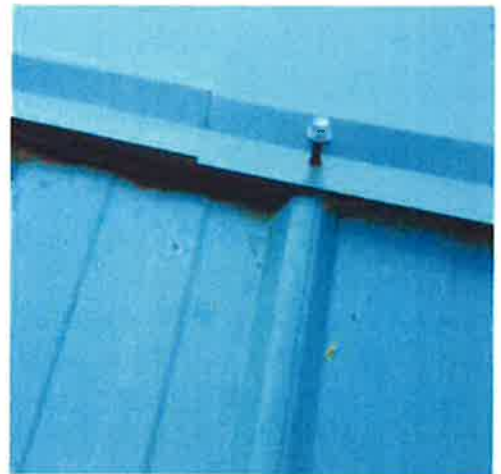
***The entire roof system is missing the roof underlayment.** This is a very important part of a roof system. The metal roofing is screwed directly to the supporting wood structure with no underlay roof membrane. This causes condensation and mold and rot to the structural integrity of the entire roof system at the locations that hold the roof together. The result is rotting wood framing and loose compression bolts, these bolts cannot be replaced again because the maximum size bolts have been used. This exposed bolting system is only expected to last 15-20 years in optimal conditions when installed correctly. These systems also require a lot of maintenance to achieve this life expectancy.

It is not recommended to try to repair this roof.

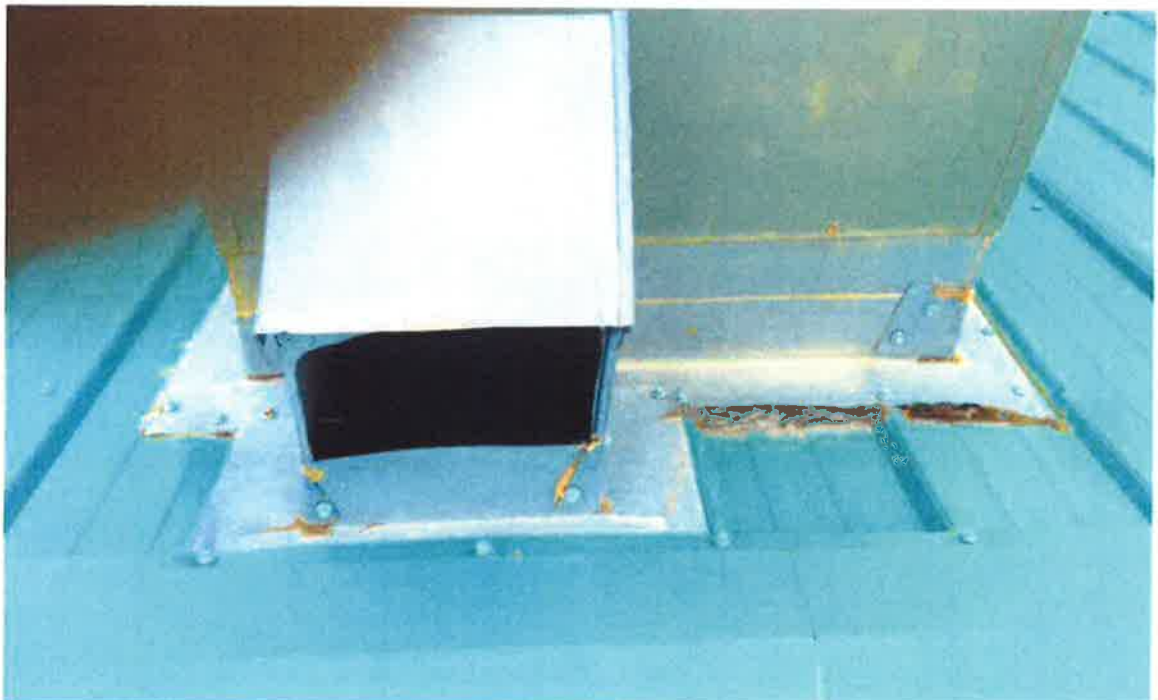
The following are only a few photographs of some of some areas of concern. These areas are definitely leaking very badly and require immediate attention. An onsite walk through would be the best way to view the severity of the water egress. There is plenty of water damage and mold growing in the attic already.

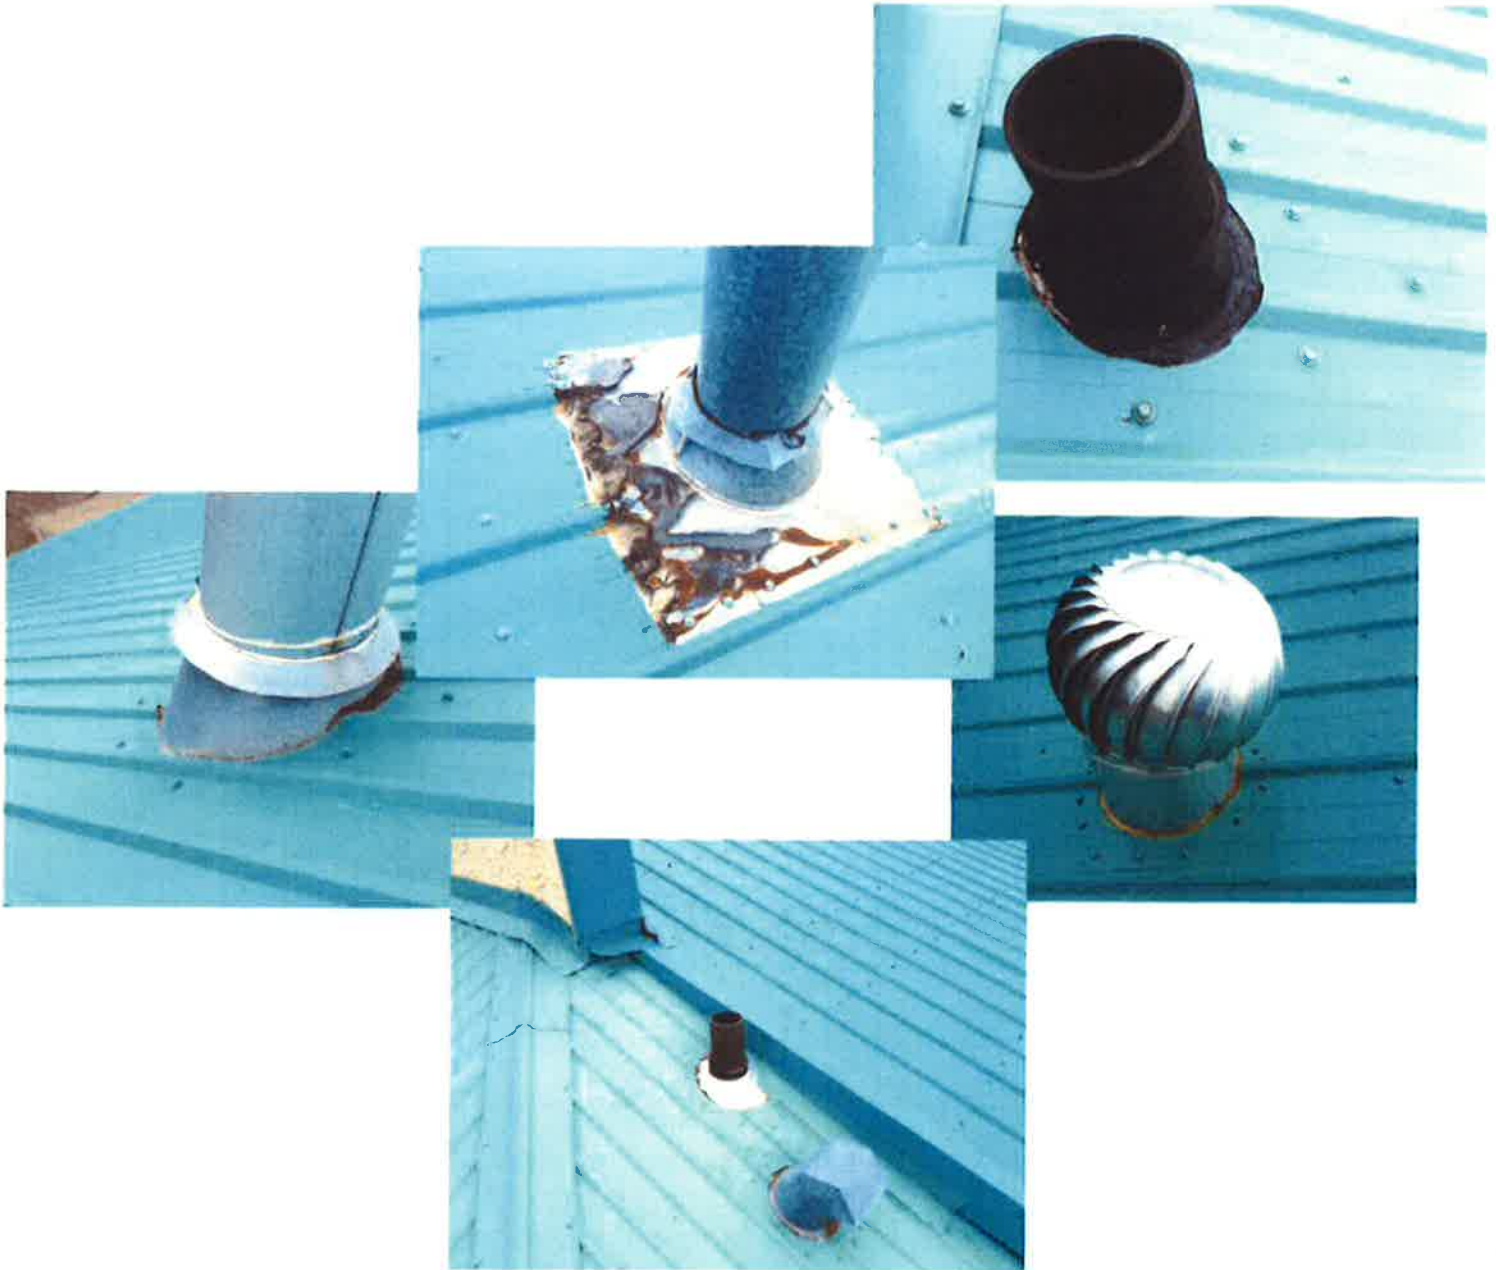
All of the roof penetrations are installed incorrectly. Water is forced directly into the lower side of the improperly lapped panels. They rely on caulking to create a water tight seal and can never be repaired. Caulking as a sealant has a maximum life expectancy of 1 year for this application before it starts to fail. These have been temporarily repaired several times already.

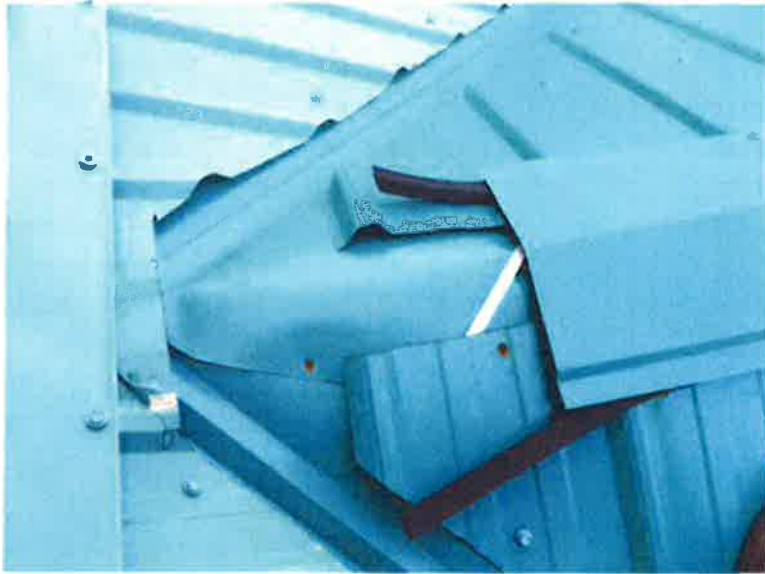
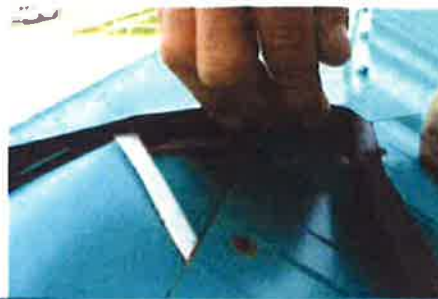
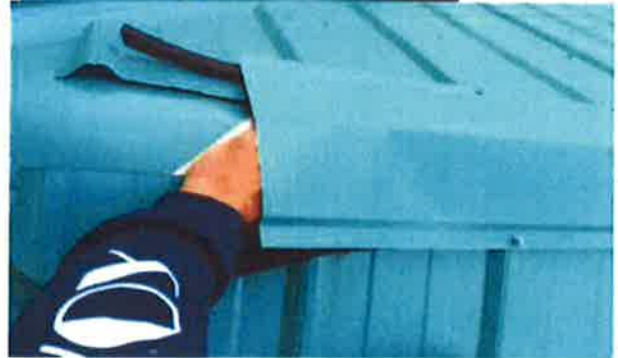
This is the current upper valley detail on the front entrance of the building. The detail was never completed and we can see that they used grinders and zip discs to cut the panels creating jagged sharp edges. Again, it was installed very poorly. And it is far from the worst detail issue.

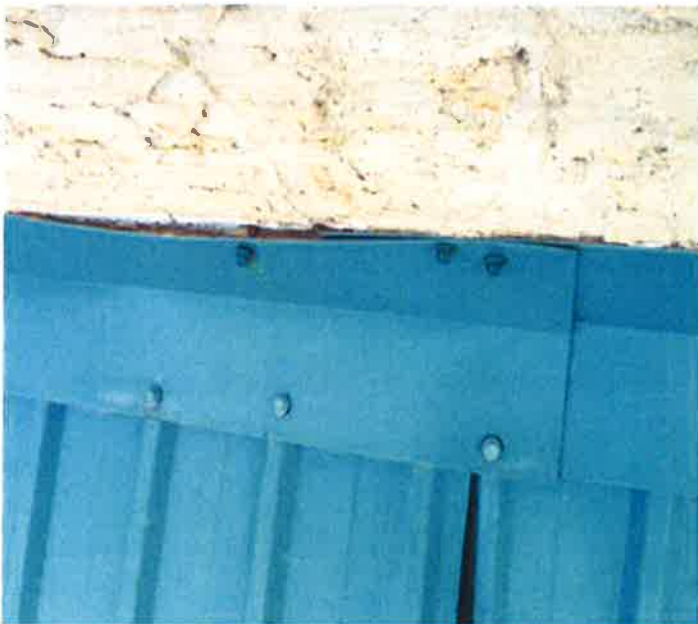
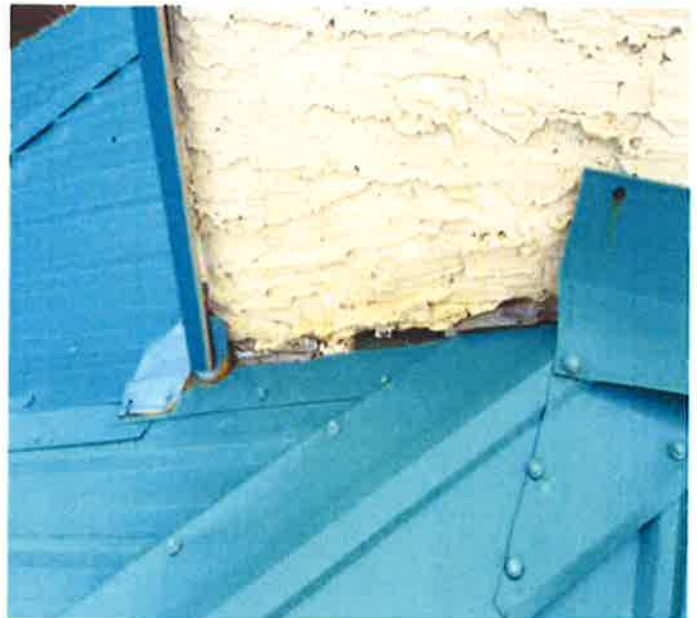
Flashings and metal roof in the front entrance area is installed on top of another shingle roof. The flashings on the stucco wall areas are fastened with compression bolts only. They cannot hold to a stucco wall without anchor plugs and so are completely useless installed this way, additionally there is no sealant or membrane to create a water tight seal. Some flashings are already blowing off.
