**Property Condition Assessment  
Update**

**Wabamun Arena**  
Wabamun, Alberta

Project No.: 116542032

August 18, 2016

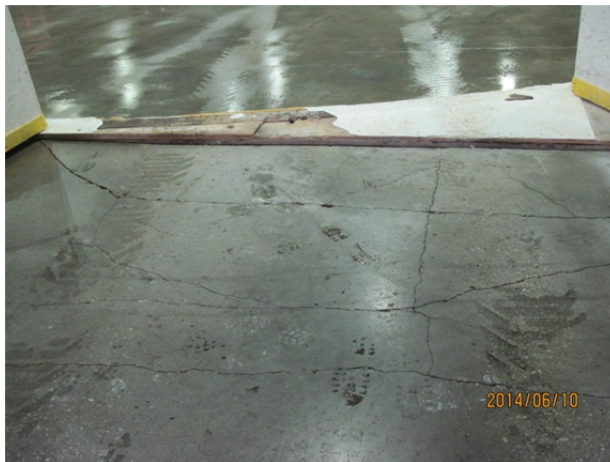
Minor surface cracking and heaving was noted in the rink slab. More extensive cracking was noted at the Zamboni's entrance to the rink surface. In 2014, Mr. McKinnon indicated that these cracks appear to be getting worse over time. Cracking was still evident during our site review in 2016. It is recommended that the Zamboni entrance floor cracks be repaired as follows:

Cracked slab at Zamboni entrance to rink

- Remove all loose slab material by light jackhammering
- Fill the crack with fine sand.
- Provide foam backing rod and flexible sealant to close the crack.

| Event Year(s) | Event Description | Opinion of Probable Cost |
|---|---|---|
| 2016 | Repair floor cracking at Zamboni entrance to rink | \$ 3,000 |

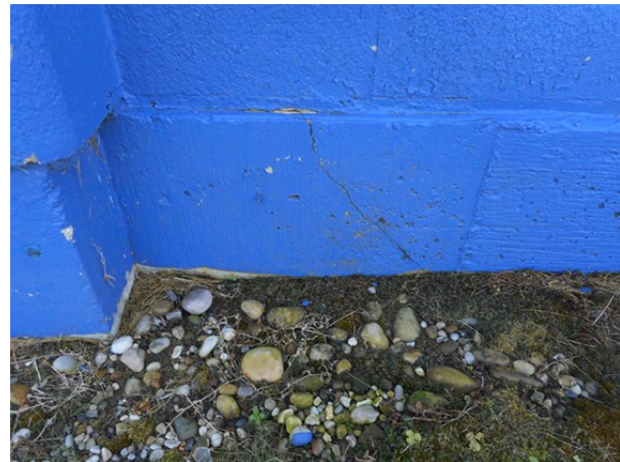
View of cracks in exterior concrete frost wall

| Event Year(s) | Event Description | Opinion of Probable Cost |
|---|---|---|
| 2016 | Seal cracks, waterproof and insulate the sub-grade north-end frost wall | \$ 18,000 |

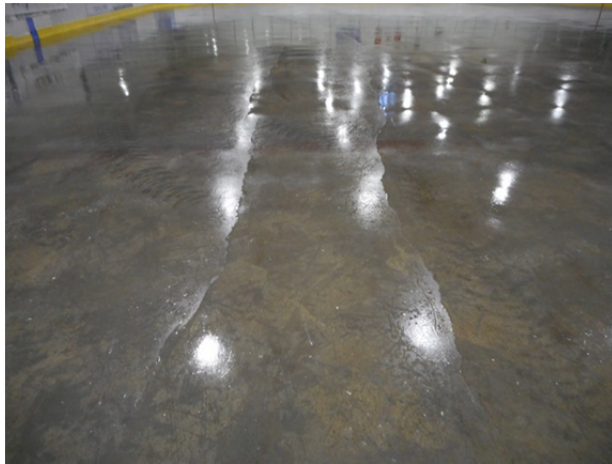
The rink slab indicated heaving in the centre of approximately 4". This was reported to create challenges in ice making and maintenance and also challenges use of the rink in the summer season. Water ponding was observed on the slab surface during our 2016 review.

Stantec was provided with an August, 2012 report which showed that the ground beneath the slab is frozen to a depth of approximately 4 feet. Current standard practice is to provide insulation below rink slabs to prevent the creation of deep frost pockets. Given the age of the building and the above observations, it is likely that there is no insulation below the rink slab.

Typical longitudinal cracks in ice rink slab

- Thaw the frost below the slab through the insertion of heating loops. These loops could be temporary or permanent and could be installed either vertically through the slab or horizontally drilled from the outside of the building. Although this will reduce the movement in the slab, it is unlikely that the existing heave will be completely eliminated.

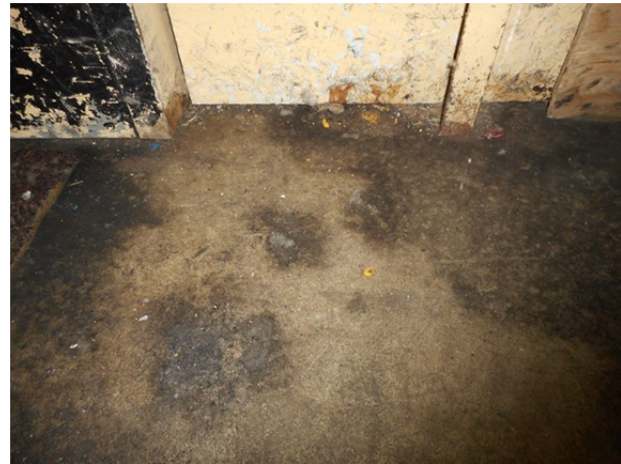
View of suspected mold growth near bleachers

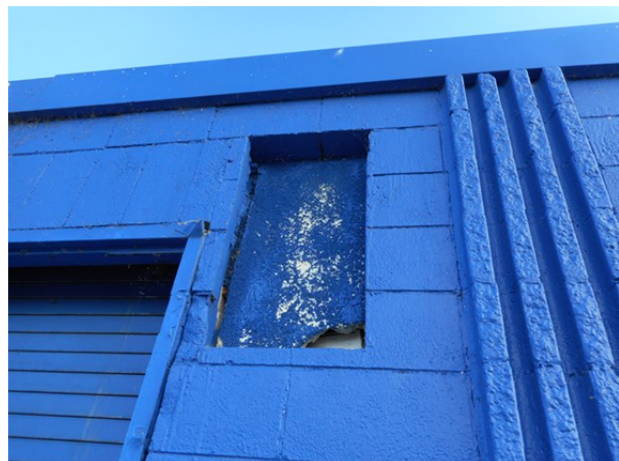
Detail of step cracking above southwest arena exit door

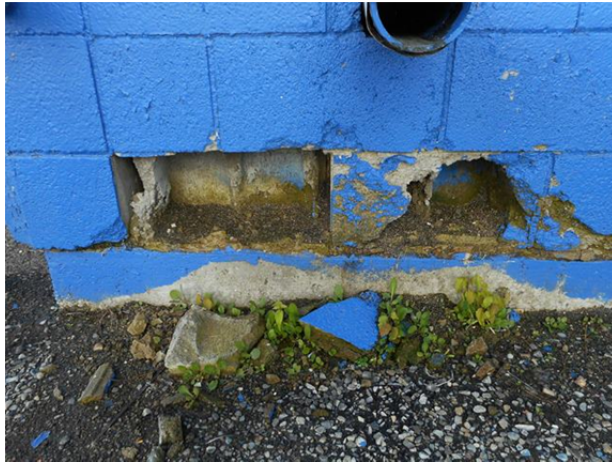
Deterioration of Arena CMU's at drainage pipe

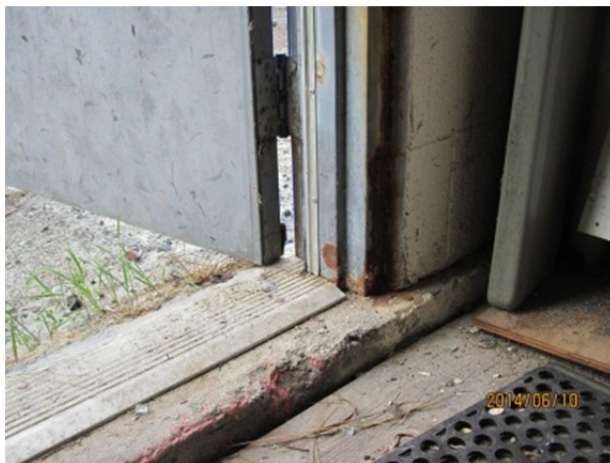
Exit door frame is rusted

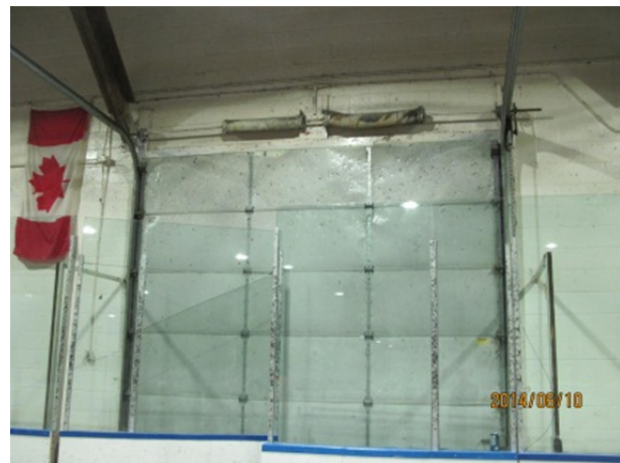
Upper portion of overhead door has a significant amount of puck damage

| Event Year(s) | Event Description | Opinion of Probable Cost |
|---|---|---|
| 2019 | Allowance to replace overhead door and frame parts , including motors | \$ 20,000 |

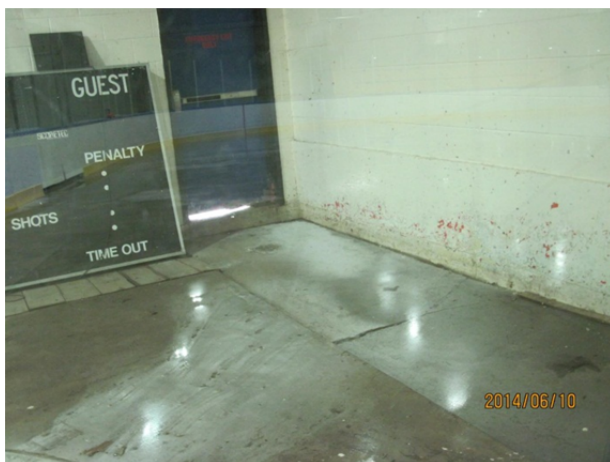
Gap under door is typical of most service doors in the Arena

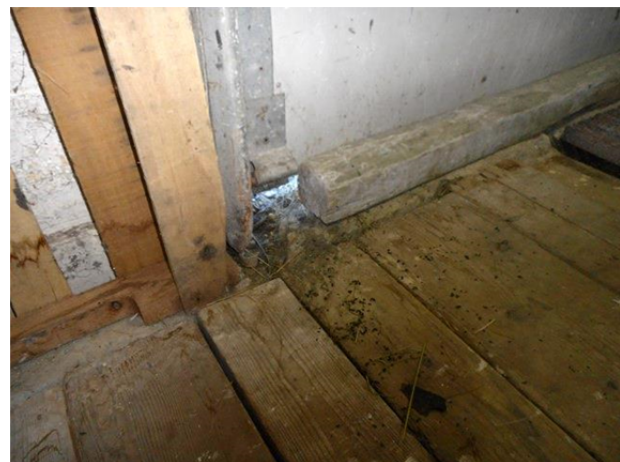
Gaps observed at base of west overhead door

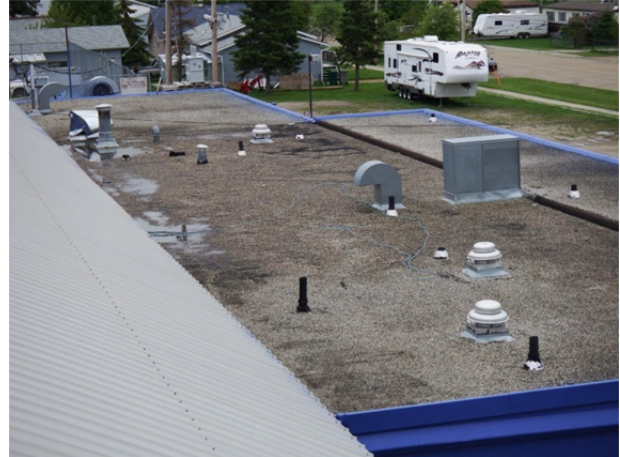
Low slope, built-up roof over change room/concession area of Arena

| Event Year(s) | Event Description | Opinion of Probable Cost |
|---|---|---|
| 2017 | Allowance for replacement of the low slope roof system of the Arena. No allowance for the addition of insulation is included. | \$ 50,000 |

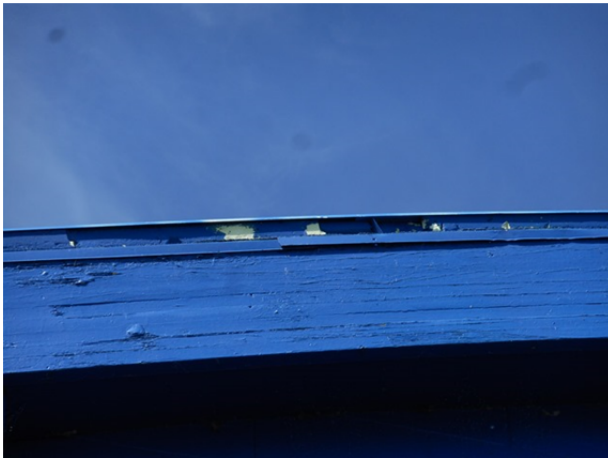
Missing fascia and exposed rigid insulation at east end of arena

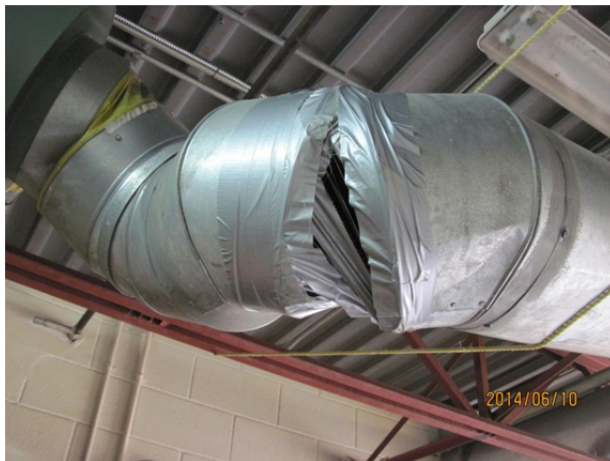
Damaged Arena HVAC duct

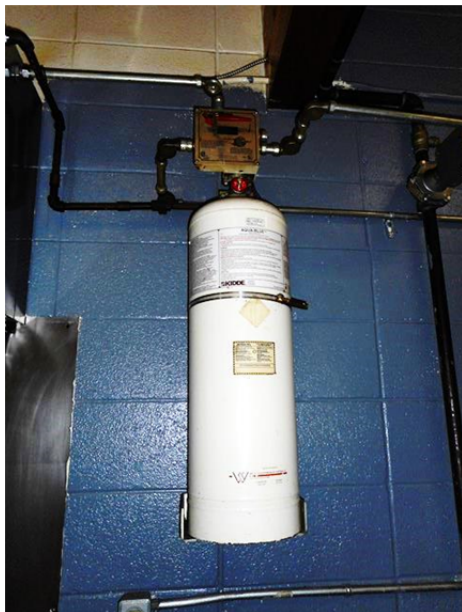
View of fire suppression system in canteen

| Event Year(s) | Event Description | Opinion of Probable Cost |
|---|---|---|
| 2016 | Allowance for replacement of canteen fire suppression system | \$ 3,000 |

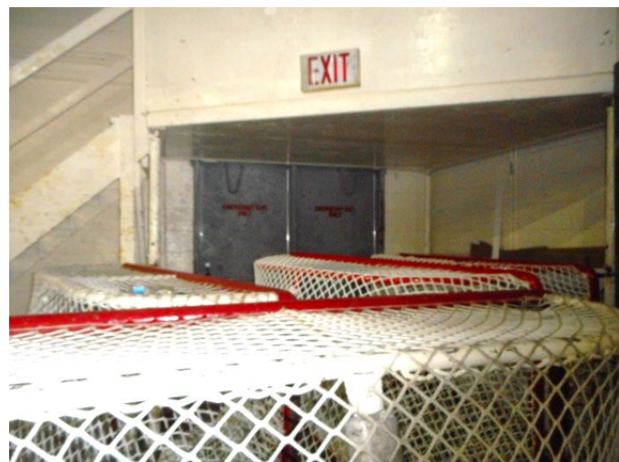
Nets are blocking fire Exit doors

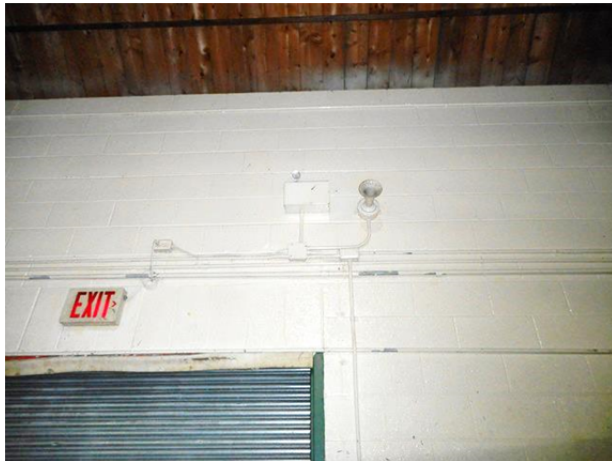
View of emergency lighting in arena; battery packs reported to be non-functional

| Event Year(s) | Event Description | Opinion of Probable Cost |
|---|---|---|
| 2016 | Replace emergency lighting and battery packs throughout the arena | \$ 18,000 |

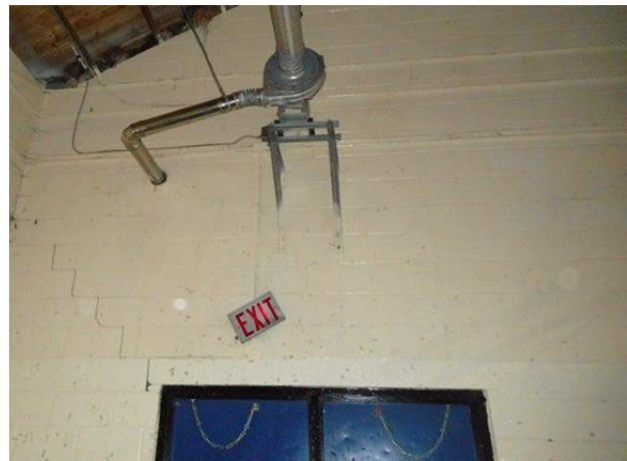
View of damaged Exit light in arena

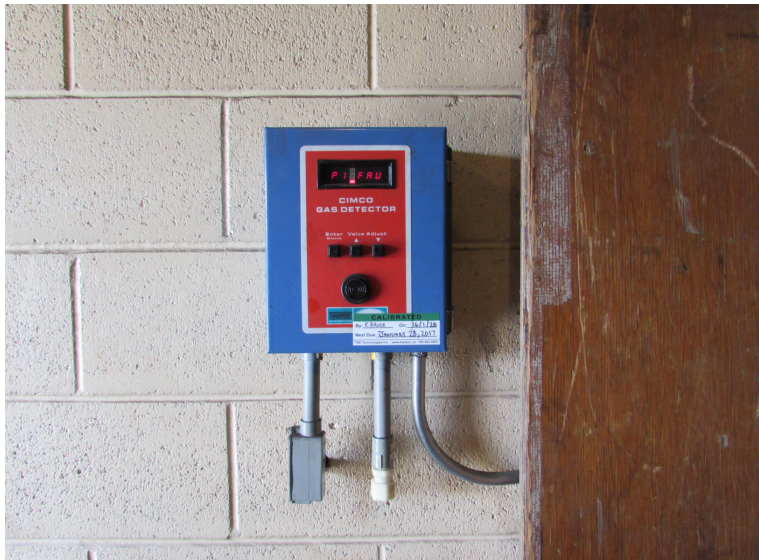
5. CIMCO gas detector showing fault

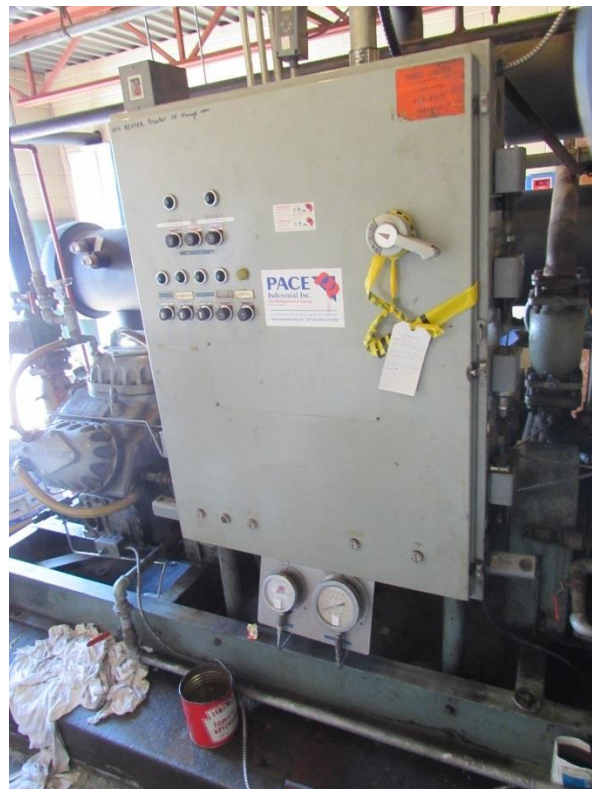
6. Outdated control system

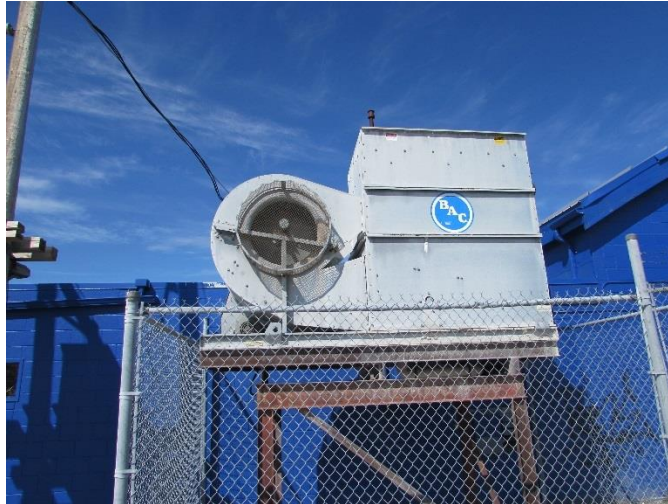
7. Undersized BAC evaporative condenser.

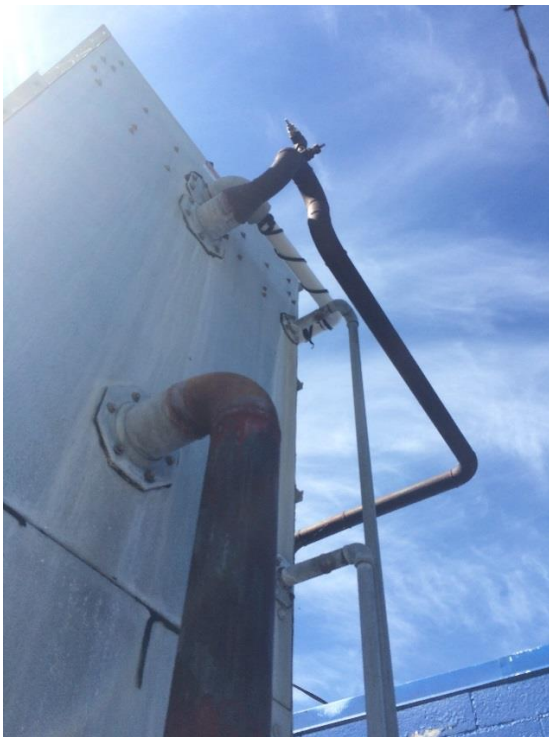
8. Condenser piping showing missing relief valve.

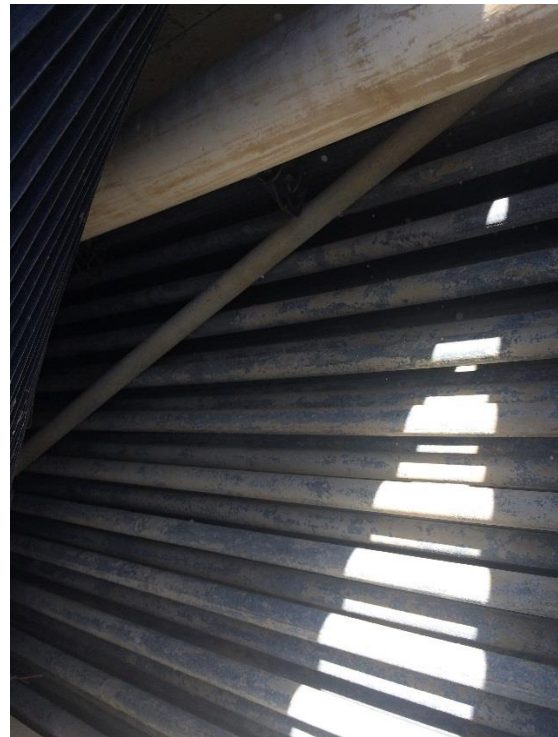
9. Condenser coil showing scaling.4. CIMCO oil separators with bracing to reduce vibration of liquid drainer.

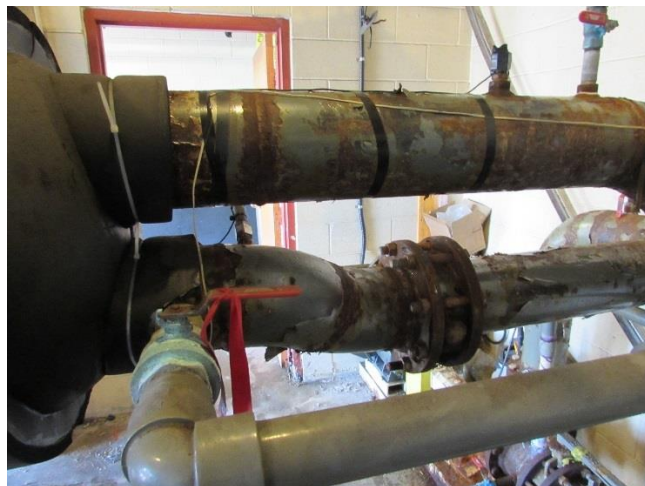
11. Brine piping showing corrosion and no insulation.

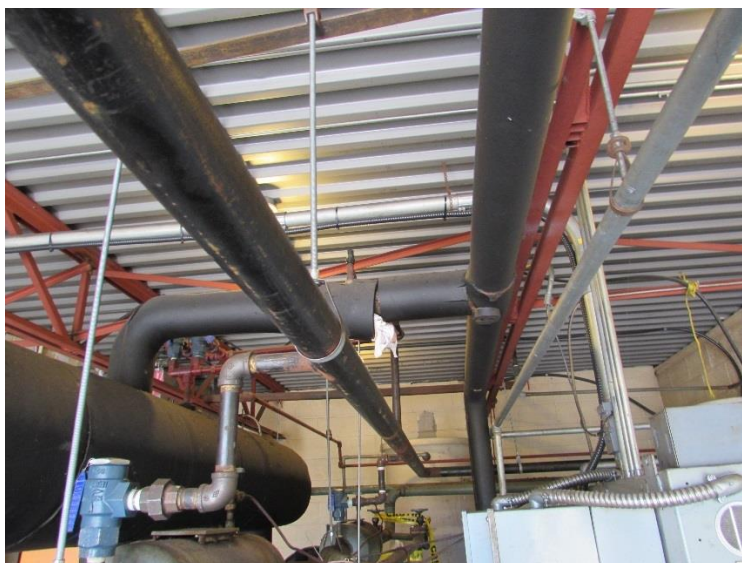
12. Suction piping showing damaged insulation.

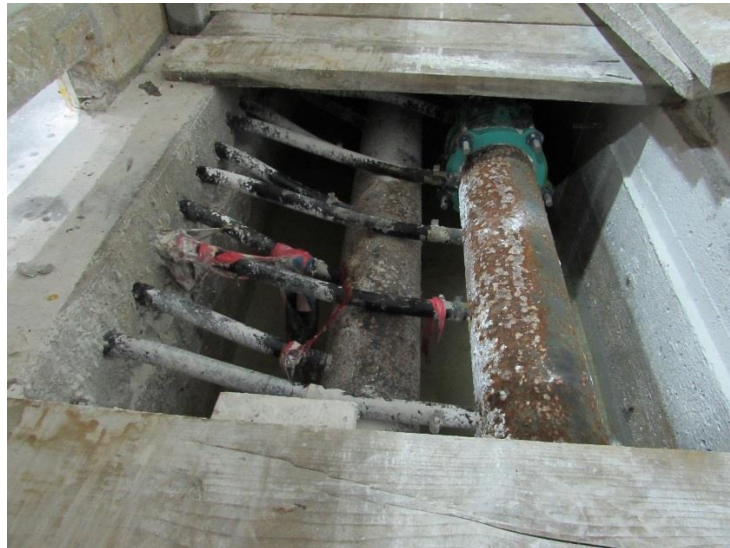
14. Headers and header trench showing corrosion, repaired header area at top, and header trench full of water and paint.

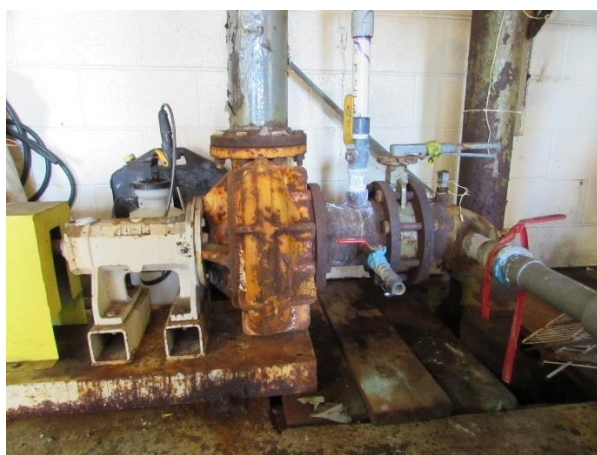
16. Cold glycol pump showing corrosion.
