PEMBINA RIVER: HIGH LEVEL BANK STABILITY REVIEW

PEMBINA RIVER VALLEY, ENTWISTLE, ALBERTA

JANUARY 9, 2018

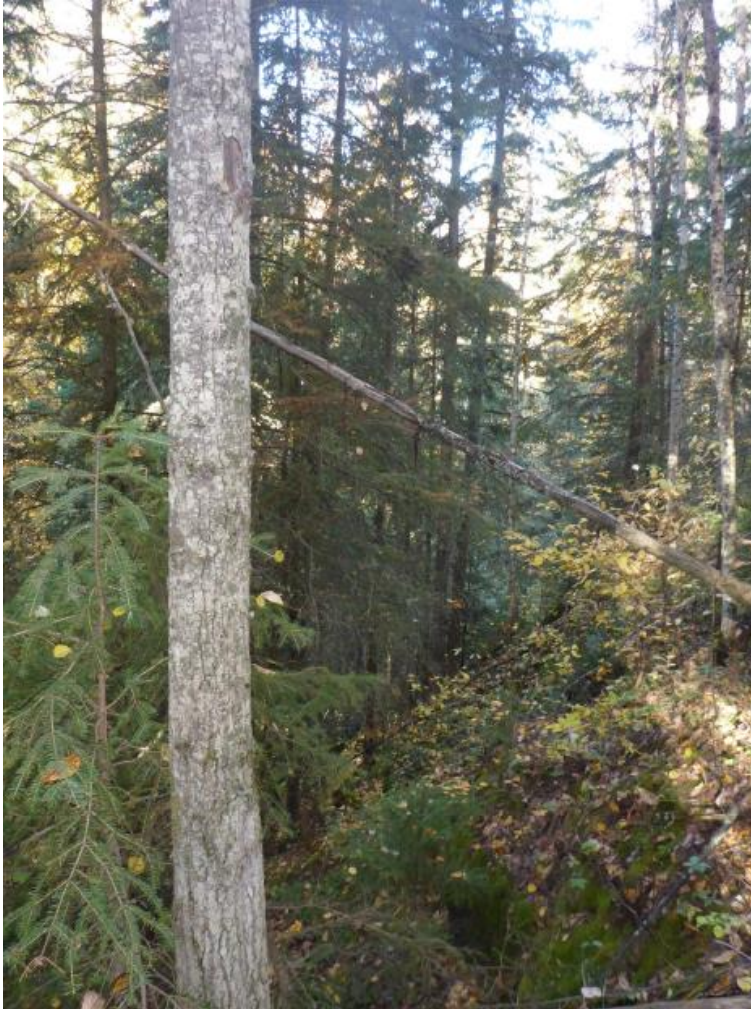
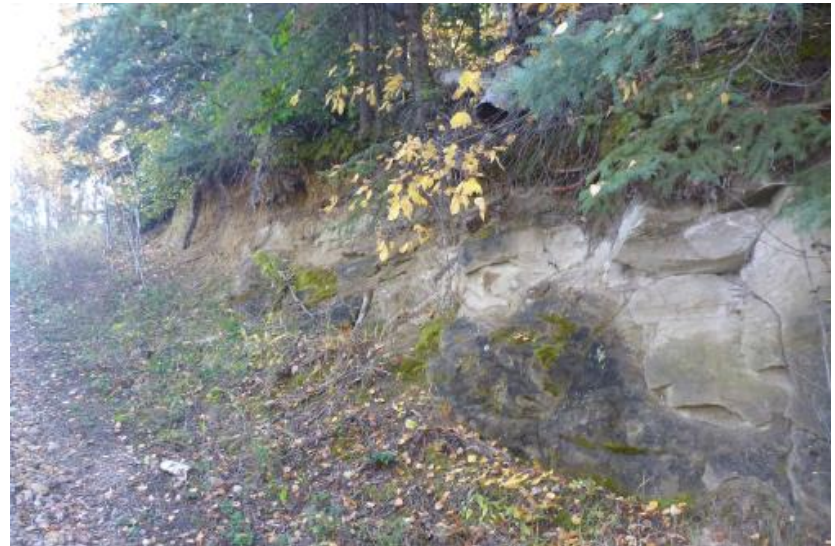
SITE 1 – WEST OF PEMBINA RIVER TUBING

Slopes appear to be relatively stable due to:

- The presence of heavy mature vegetation
- Little encroachment by human activities
- The presence of very shallow bedrock

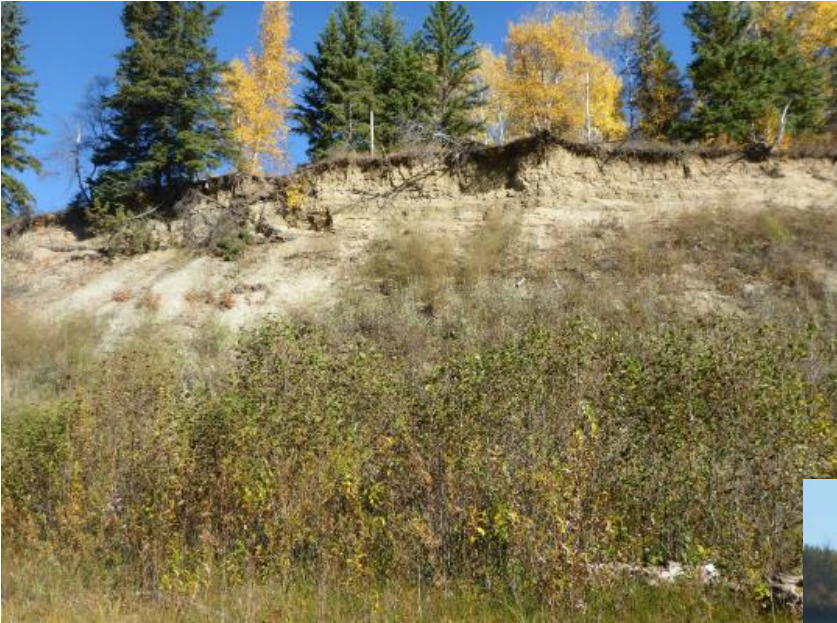
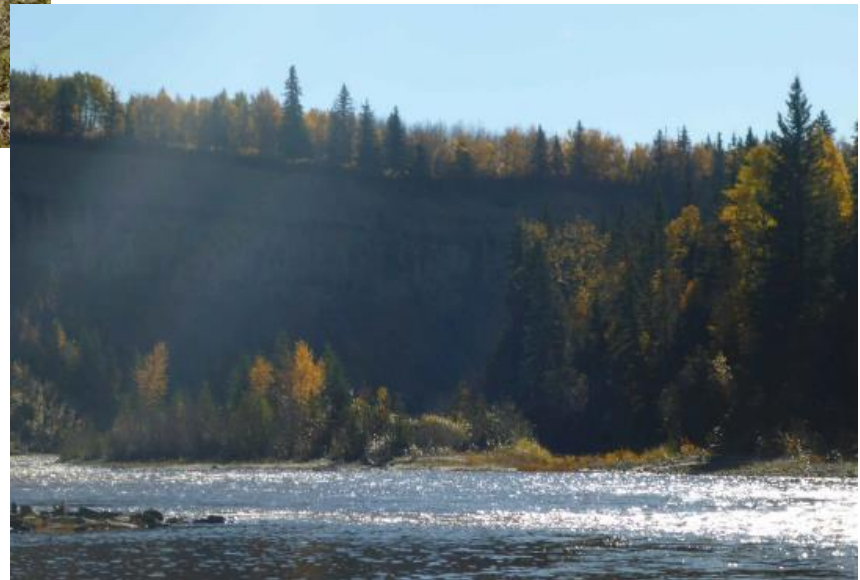
SITE 2 – WEST OF 55 ST. AND SOUTH OF 46 AVE.

- This landslide occurred decades in the past.
- Lower slopes feature mature vertical vegetation with some bare areas that may be experiencing minor surface erosion.

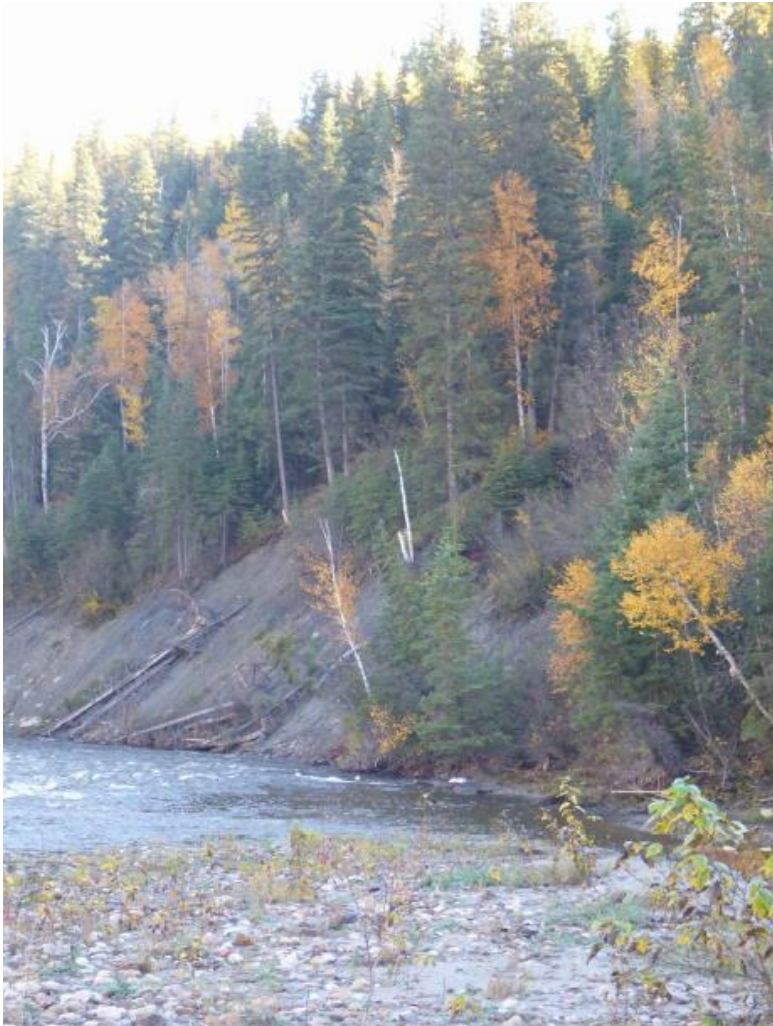
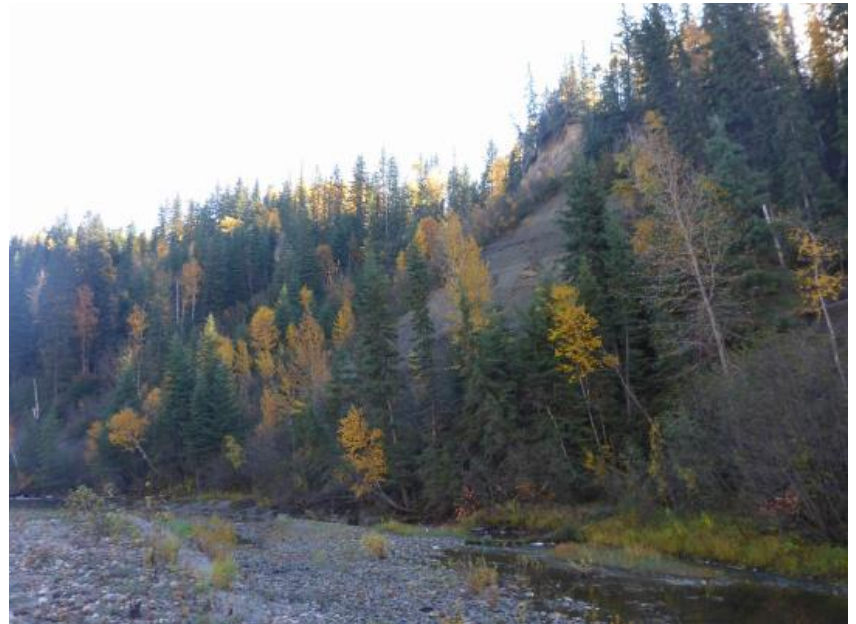
SITE 3 – WEST OF 55 ST., NORTH OF 46 AVE. AND SOUTH OF HIGHWAY 16

- The southern end of site 3 is experiencing either fairly recent and/or continuing landslide activity.
- No habitable structures should be immediately effected.

- The location of the recent and/or continuing landslide activity at the southern end of Site 3 should be periodically monitored through visual inspection.
- Inspection should be undertaken at semi-annual intervals, in the early summer following spring run-off and again prior to winter.
- If the failure is observed to be ongoing, remedial measures may be required.

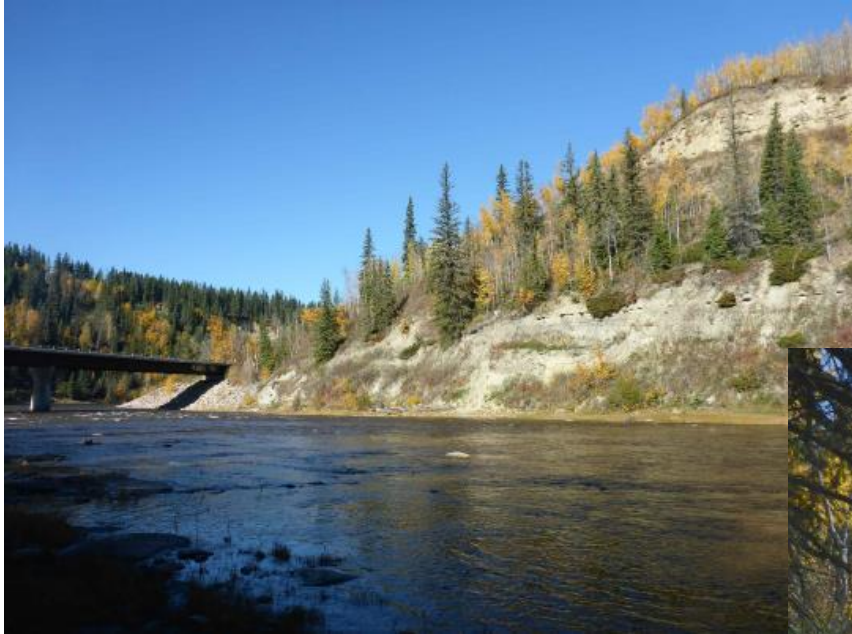
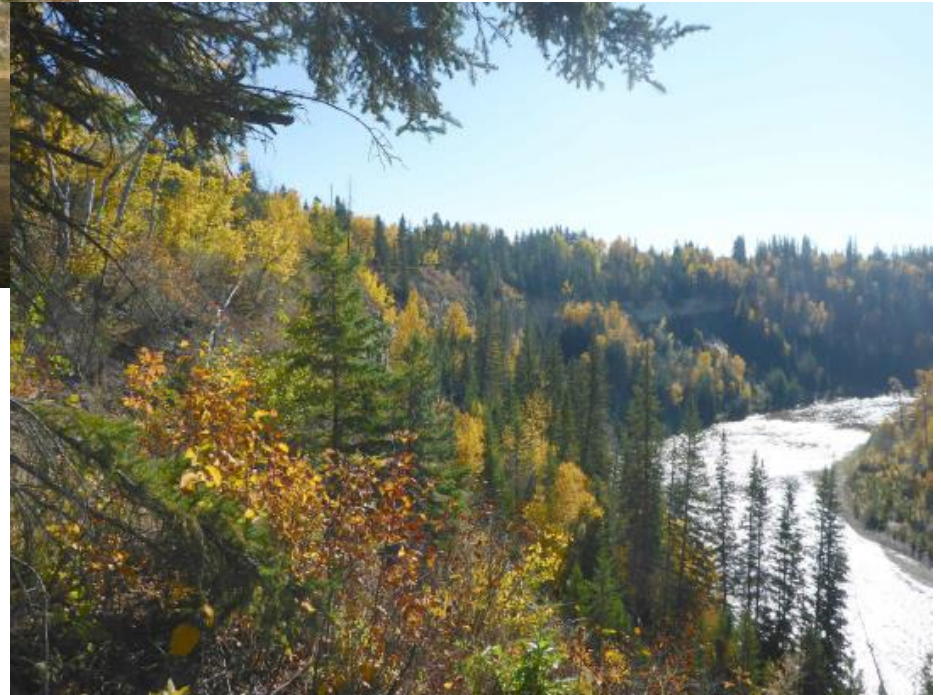
SITE 4 – WEST END OF TWP 534

- Heavily forested with mature vegetation.
- Exposed sandstone vertical faces appear to be stable.

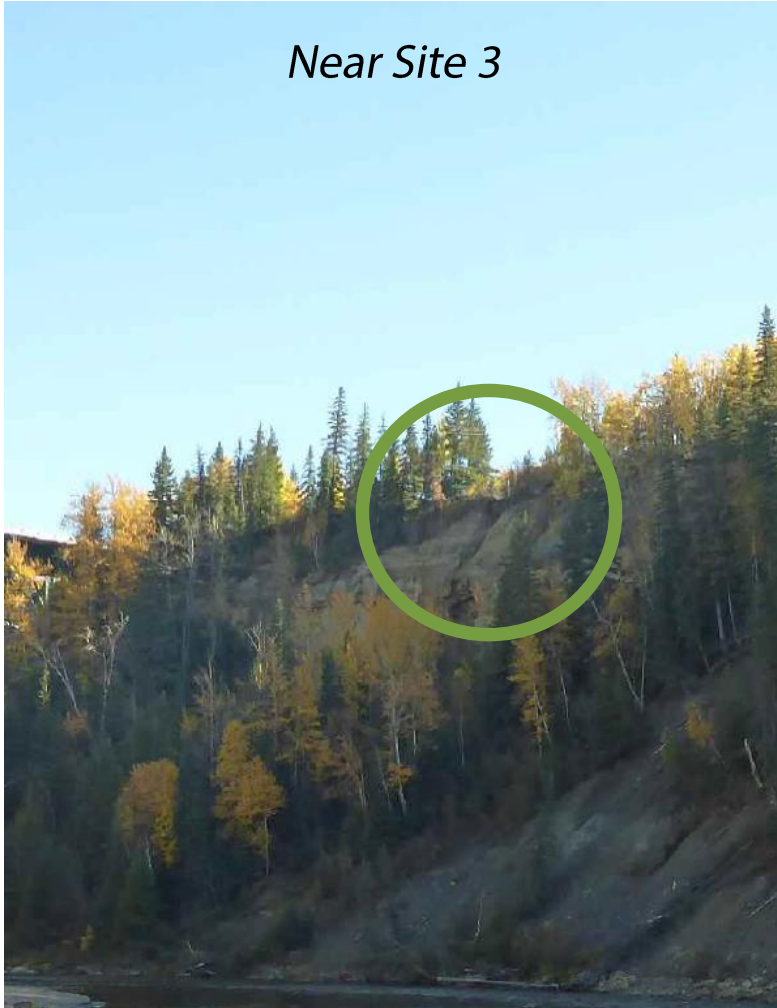
Near Site 3

- There are five locations where concentrated overland flow is occurring over the Pembina River banks causing erosion.
- If left unabated, this erosion will continue during surface runoff events and over time will remove overburden soils down to exposed bedrock.
- It is not expected that that the erosion down to bedrock will cause overall instability to the valley slope. However, it is possible that the erosion of the overburden soils in these areas could progress eastward from the crest of the slope, destabilizing some of the near crest areas.

- Erosion control measures should be employed at the five locations where concentrated overland flow is occurring over the Pembina River banks.
- Repair could require regrading, armoring the crest and upper banks with rip-rap, erosion control blankets, or a similar engineered method.
