January 21, 2019

Mallard Park Drainage Assessment

MALLARD PARK DRAINAGE REVIEW

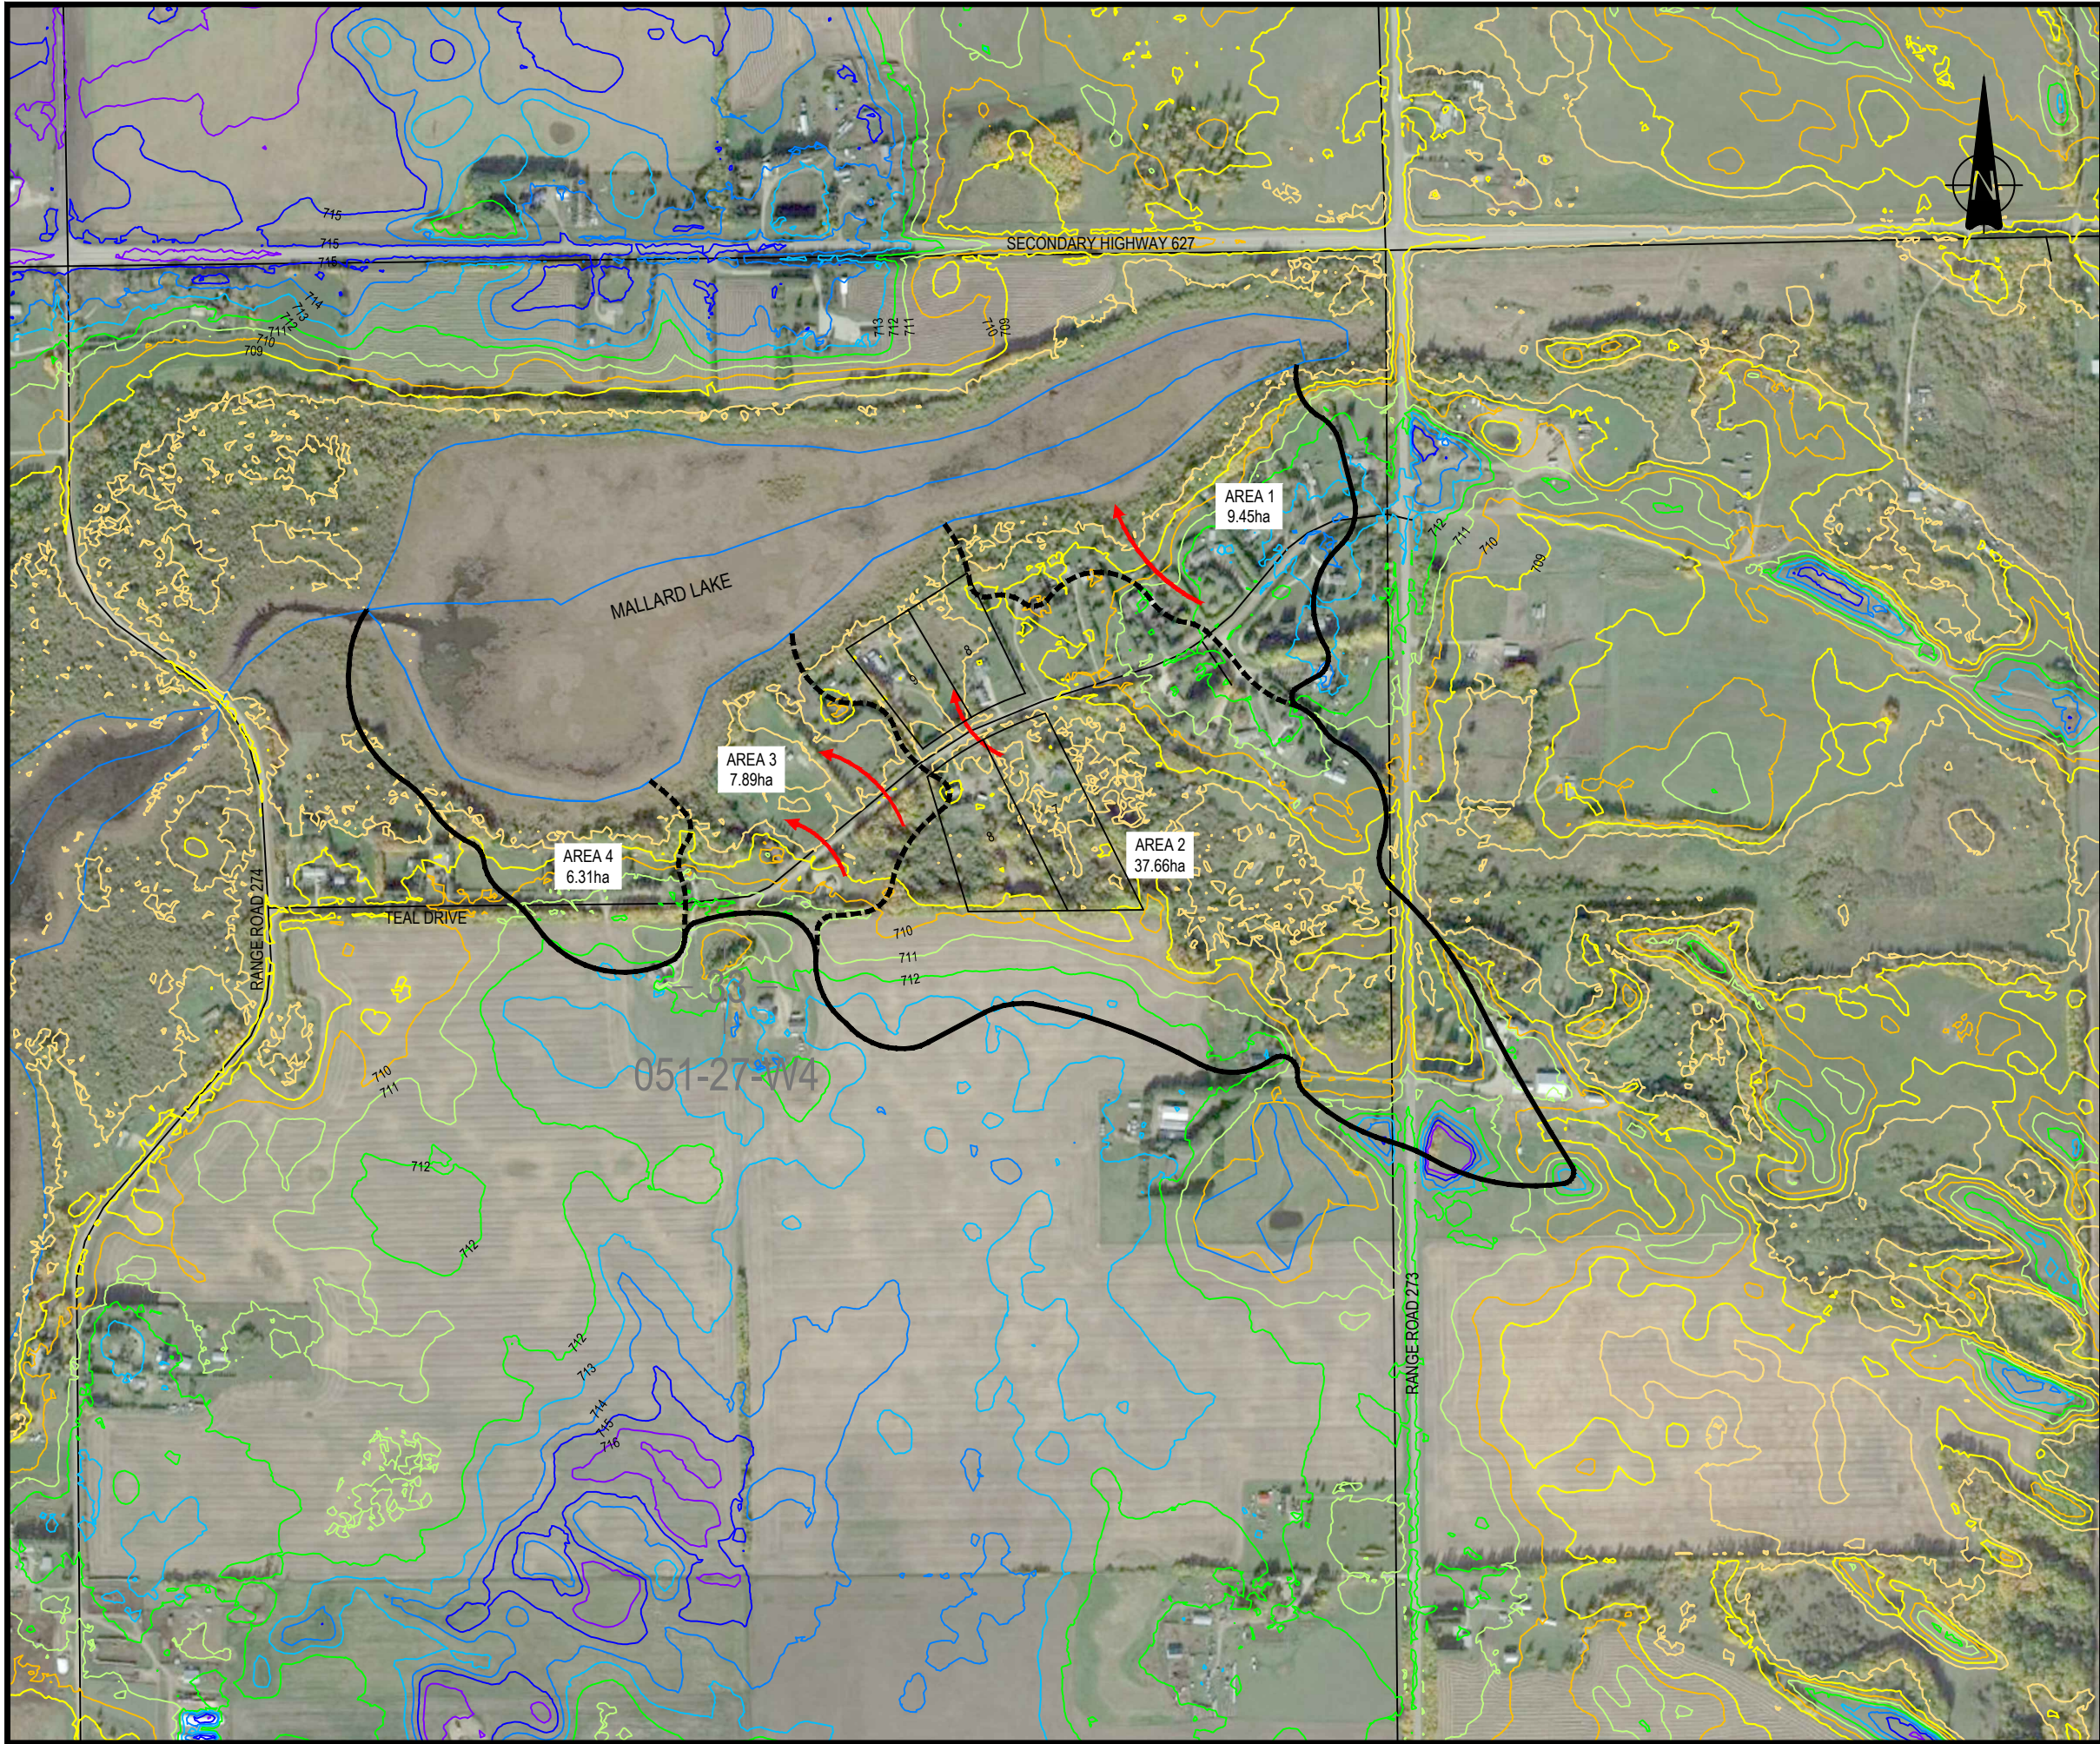
Scale:	1:8000	Figure:	1
--------	--------	---------	---

The contributing drainage area to Mallard Lake is primarily from the north and northwest. The four residential lots in question are located along the south side of Mallard Lake. The contributing drainage area to the four lots (area 2) is primarily from the southeast towards northwest and is approximately 38 hectares (ha) in size, as shown on Figure 1.

Figure 1 shows that the natural drainage through the Mallard Park Subdivision is primarily from the southeast to northwest, into Mallard Lake. The primary outlet into Mallard Lake is through that area along the lots 8 and 9 property boundary, north of Teal Drive, as shown on Figure 2. Therefore, to maintain that natural drainage path, a culvert across Teal Drive is required in the general location of the existing County culvert.

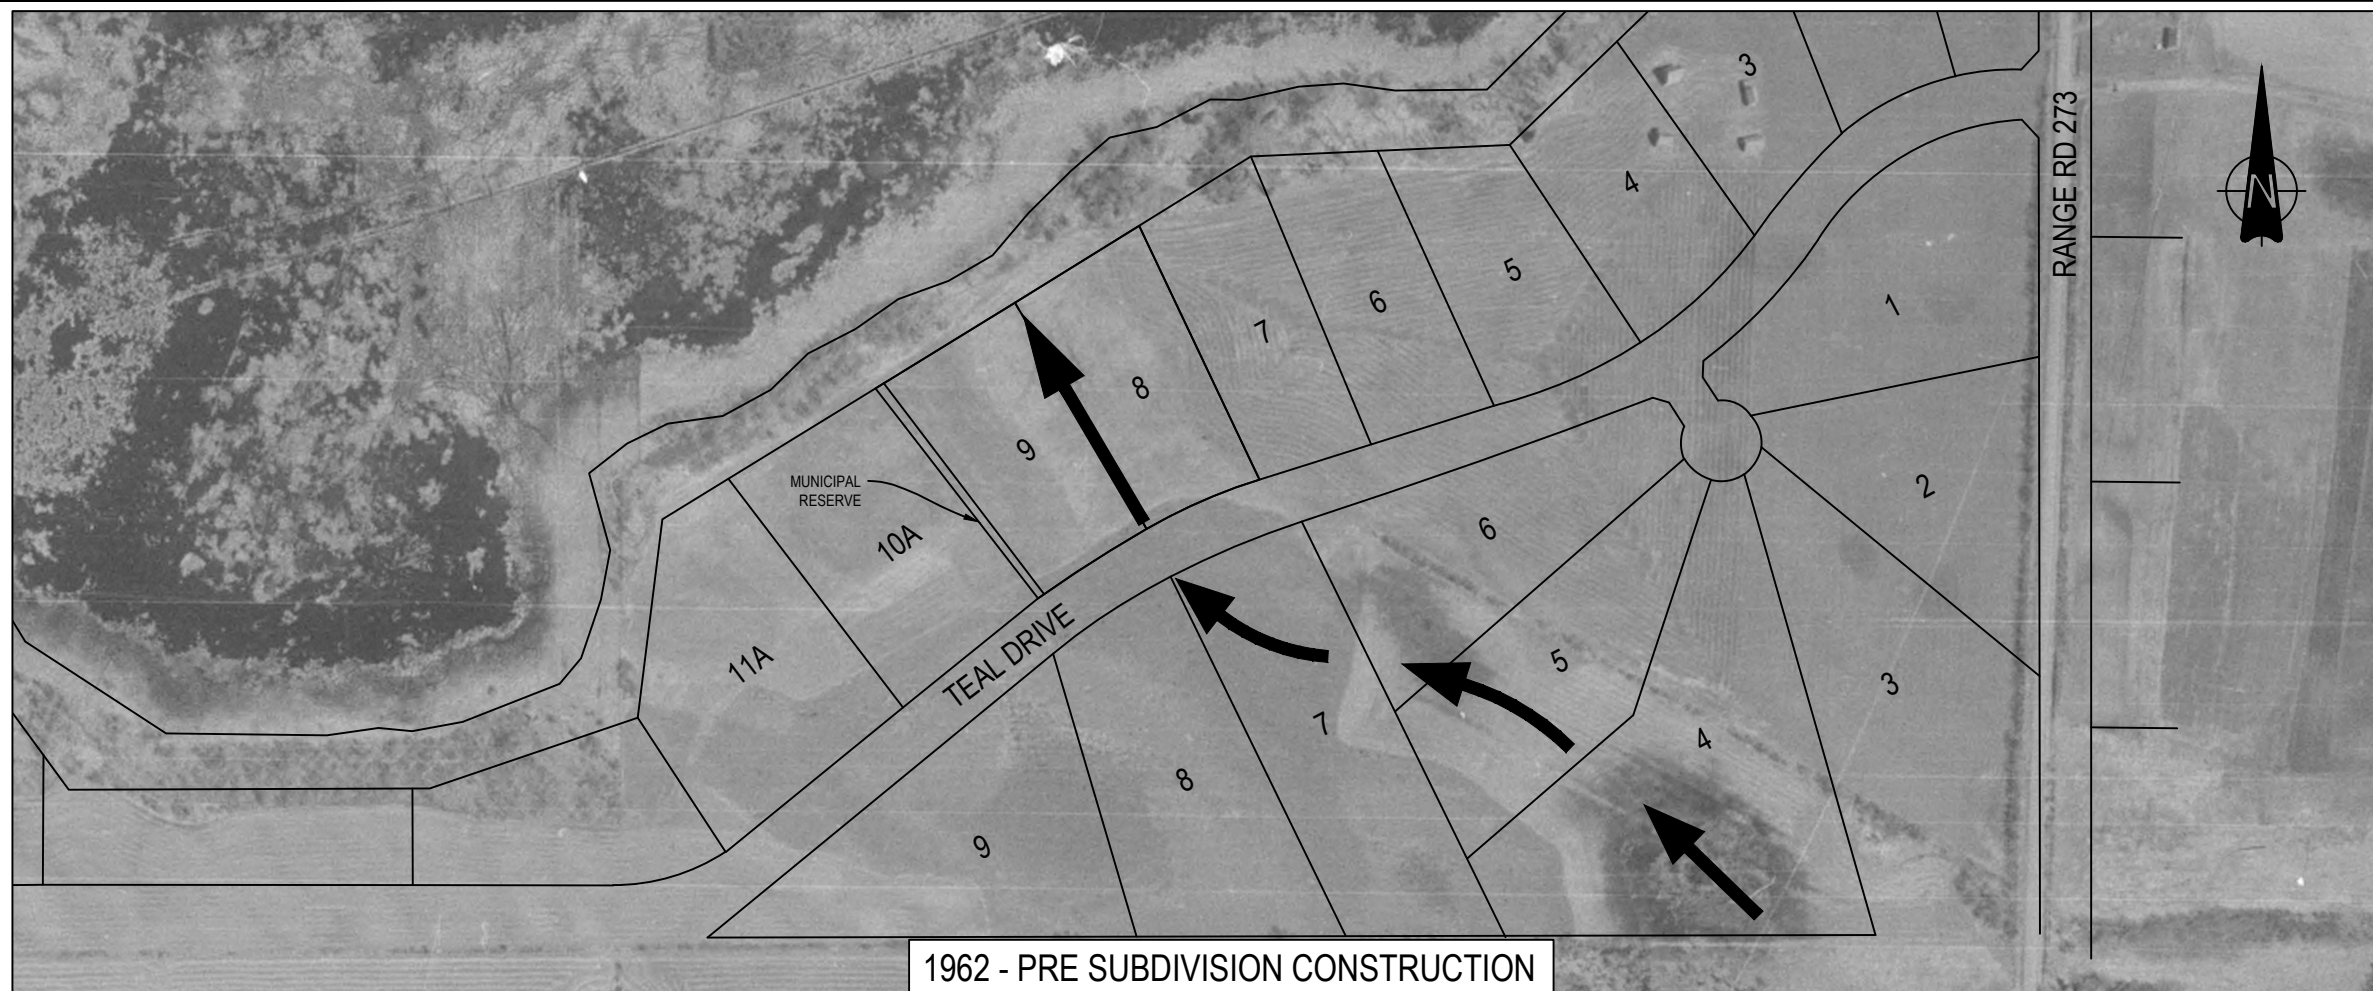
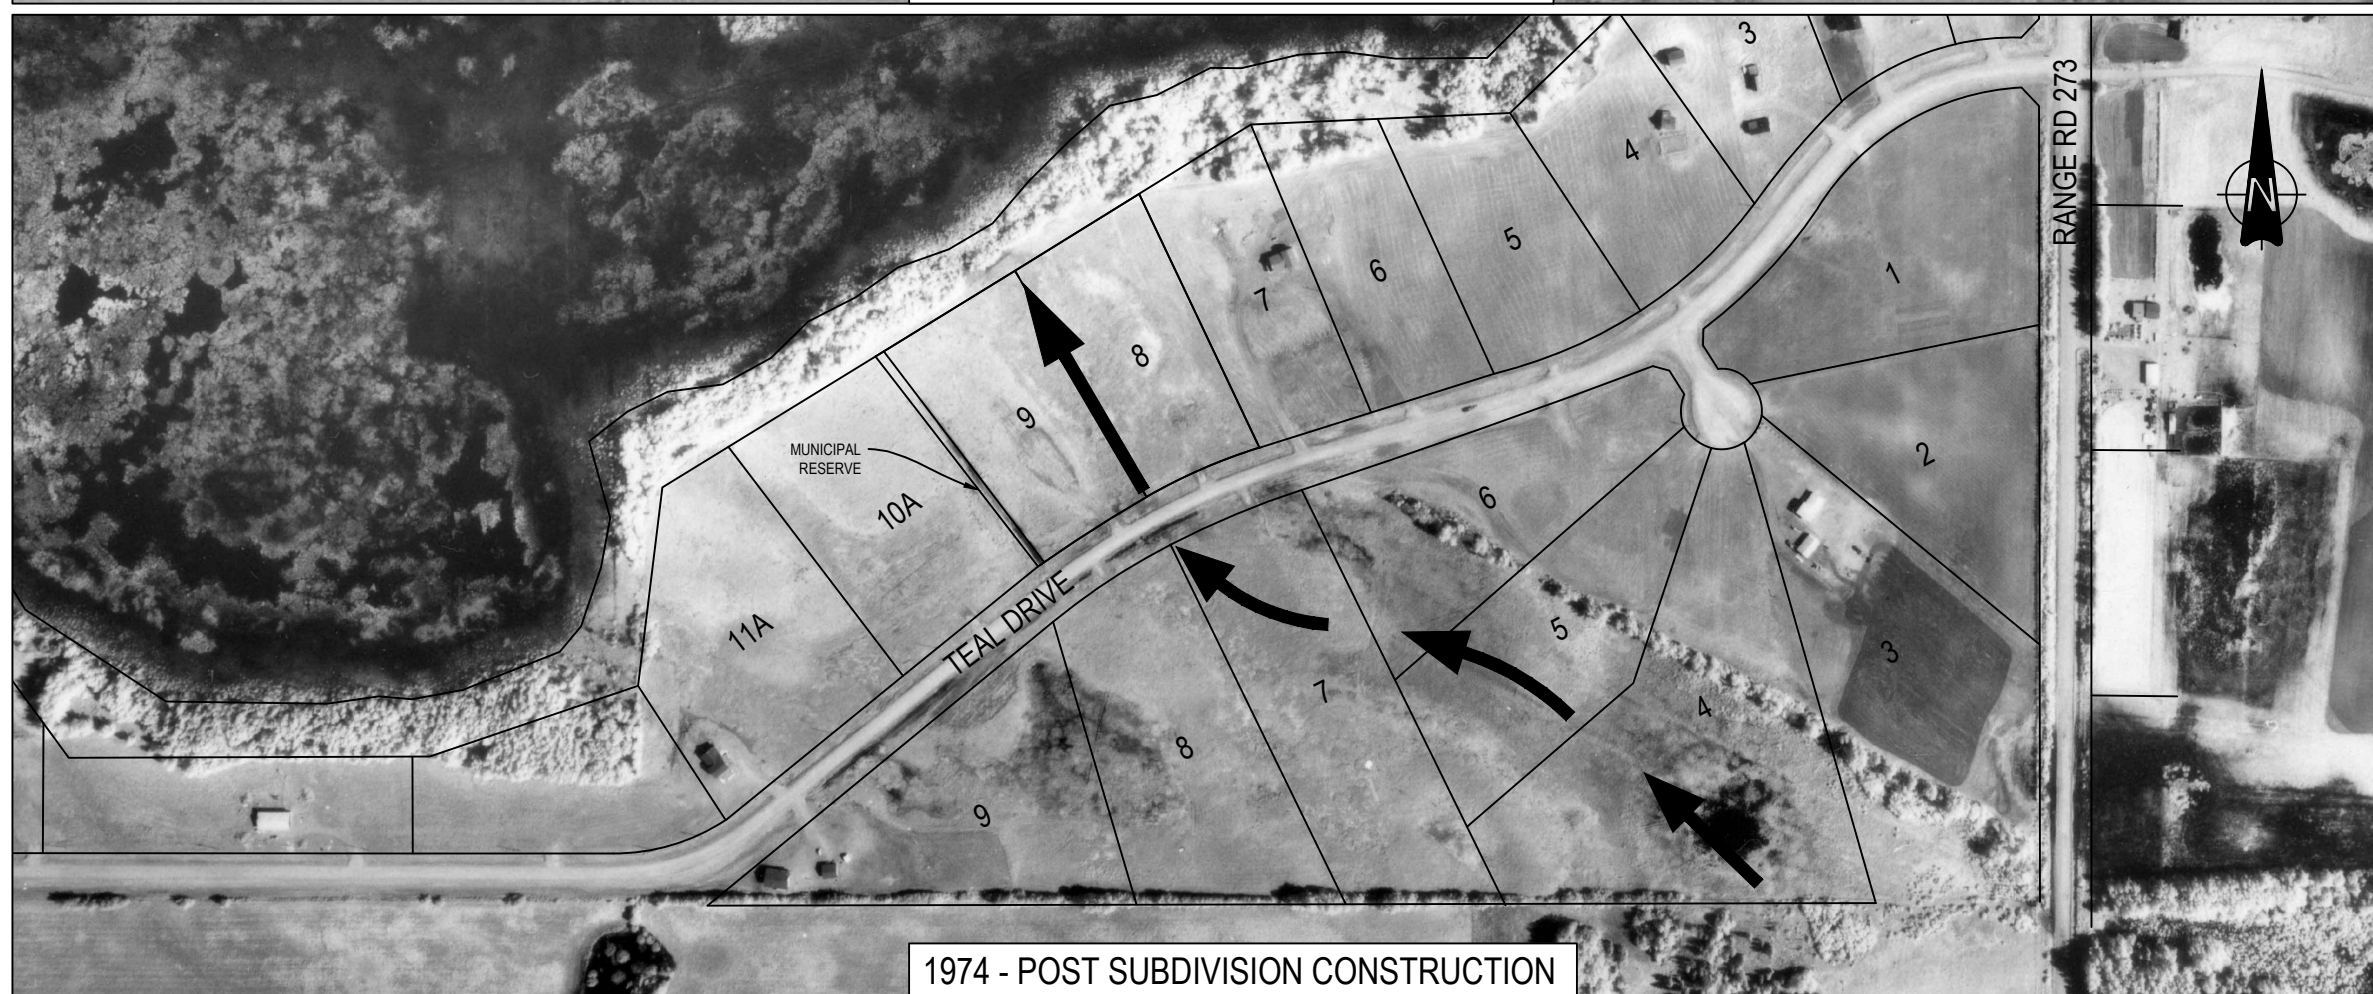
MALLARD PARK SUBDIVISION
 MAY 1962 AND JUNE 1974

Prior to the development of the Mallard Park Subdivision, the N½ 33 was in agricultural cultivation with a narrow riparian area left around Mallard Lake. Figure 2 shows the 1962 (pre-subdivision construction) and 1974 (post-subdivision construction) air photos with the Mallard Park subdivision superimposed on them. The air photos show the natural drainage pattern commencing in the southeast corner of the subdivision and traversing the subdivision in a northwest direction, through lots 7 and 8, south of Teal Drive, and lots 8 and 9, north of Teal Drive, into Mallard Lake. No low spots, or water ponding, are evident on lots 7 or 8, south of Teal Drive to suggest that the drainage pattern does not continue north through lots 8 and 9, north of Teal Drive. Therefore, the natural drainage pattern from the southeast is directly through the area of dispute, to Mallard Lake without any apparent obstruction. This remains to be the case for some time after the development of the subdivision and the development of Lots 8 and 9 north of Teal Drive.

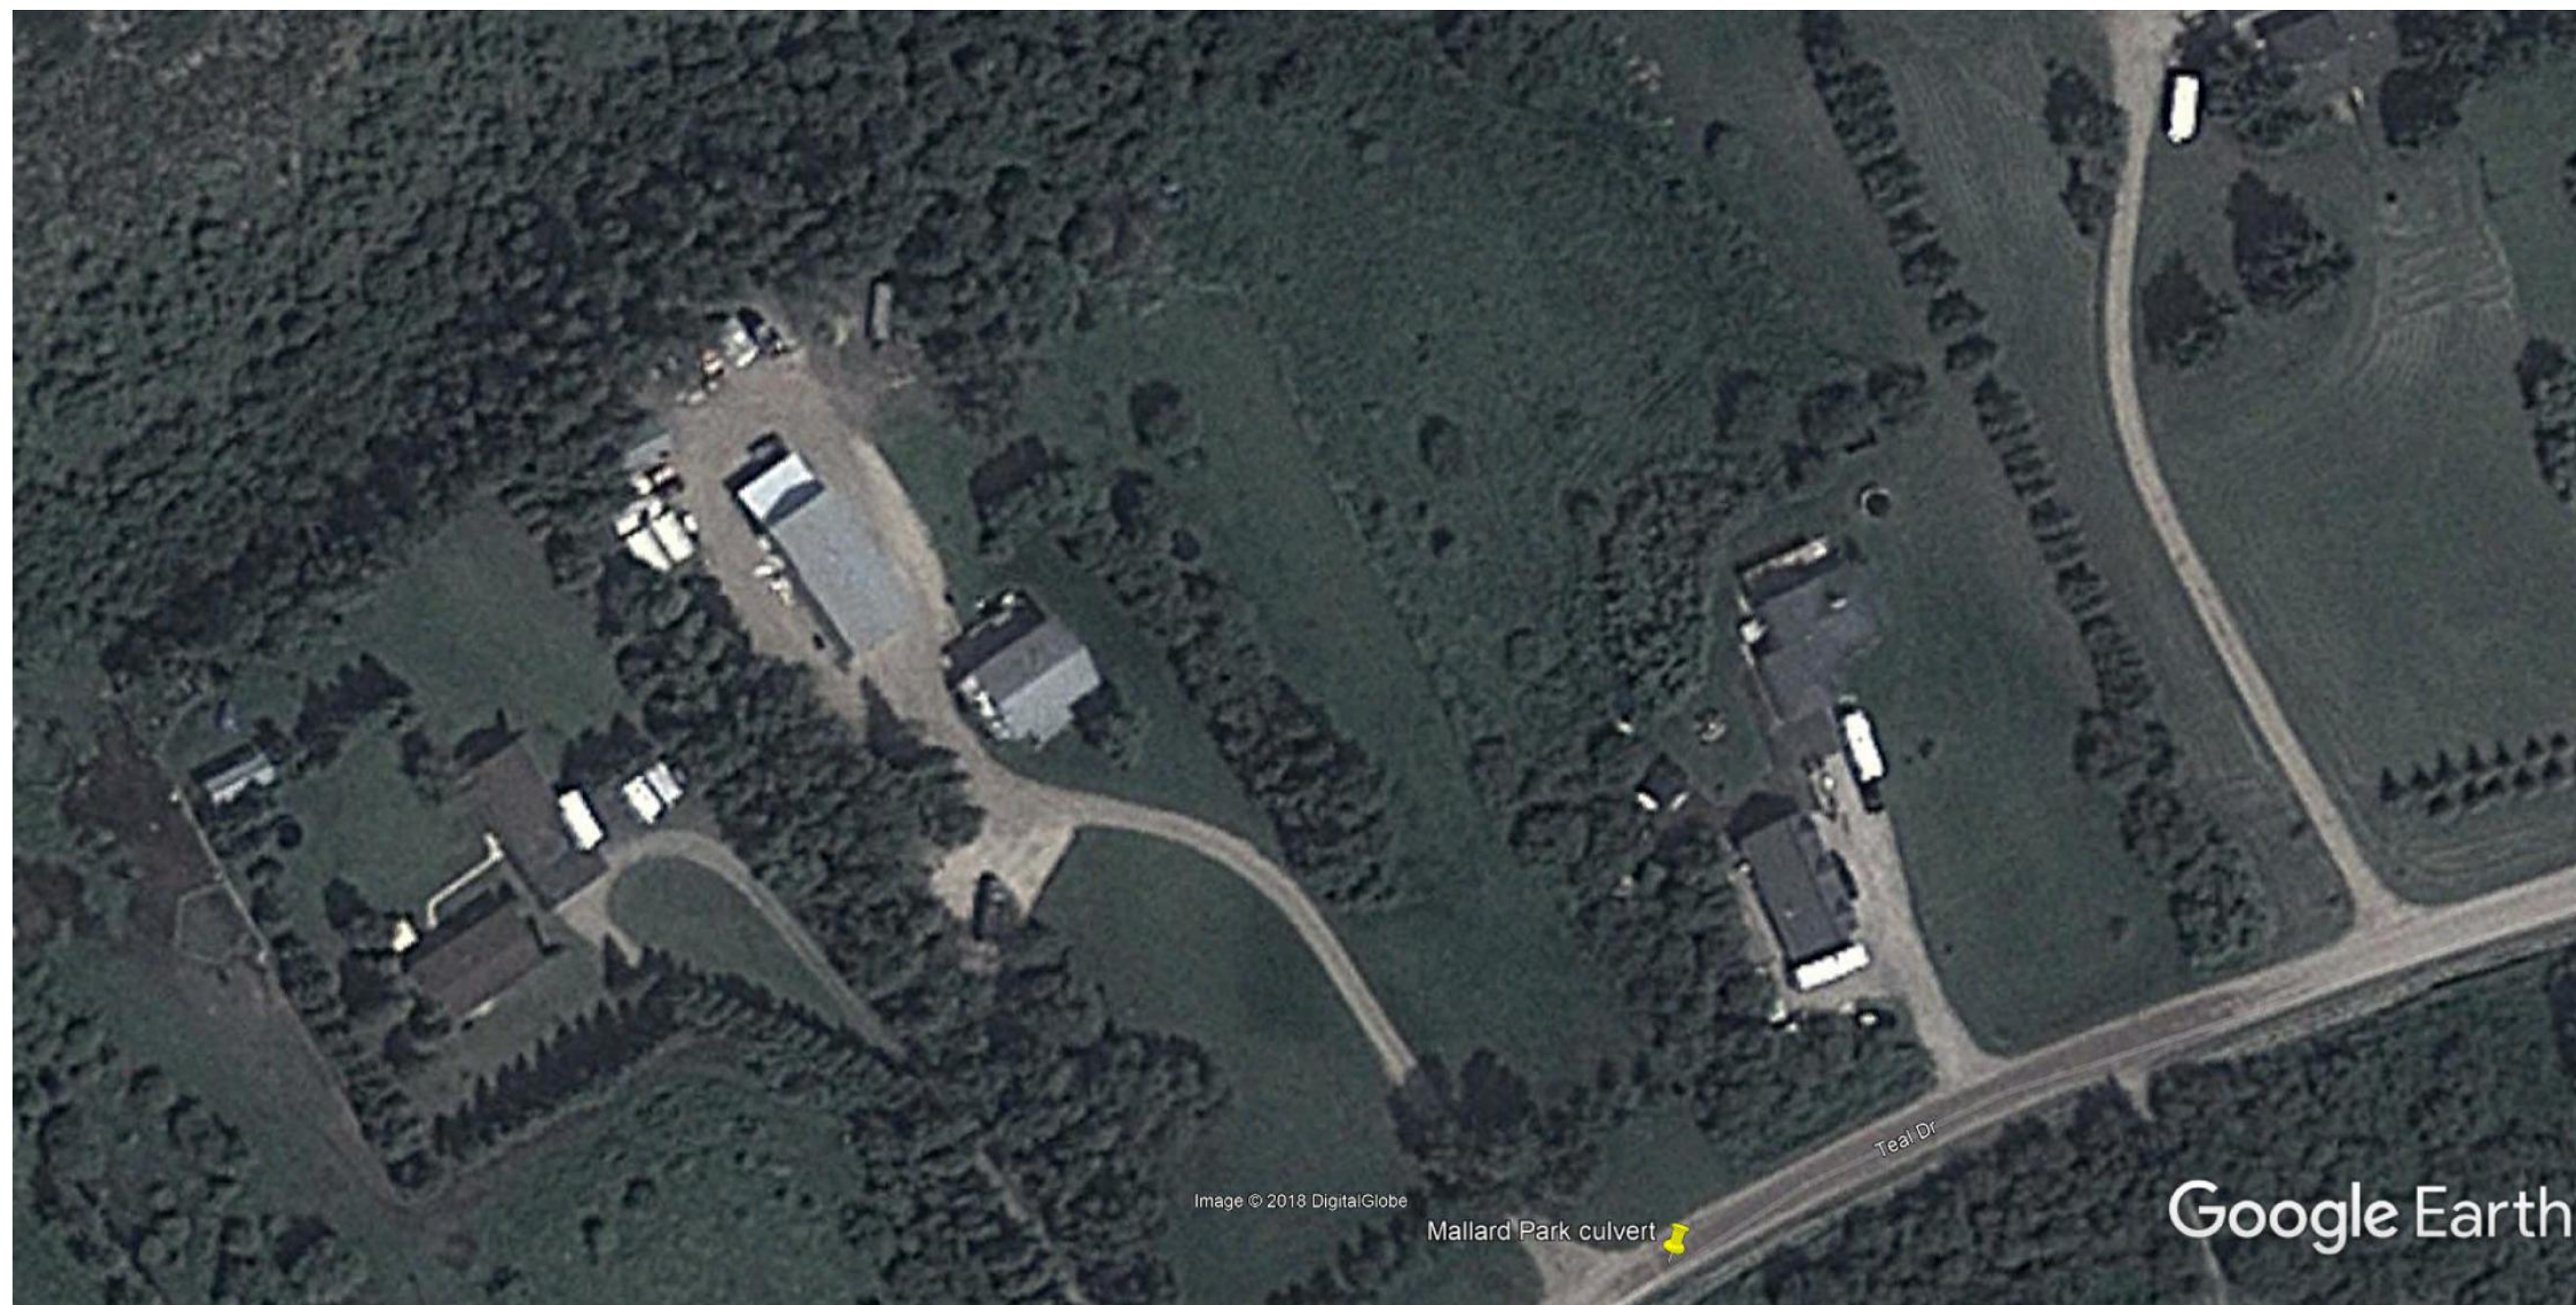
Google Earth Imagery – August 4, 2011

The 2011 and subsequent orthophotos suggest that vegetation has been cleared and fill material brought in and placed in the northeast corner of lot 9. This activity is corroborated by the Google Earth imagery, which shows the area filled and stockpiles of fill materials located on the filled area. In addition, the 2016 orthophoto shows, what appears to be, a constructed drainage path through the fill area, which extends to the north, into the riparian area. That drainage path is not apparent in the 2017 Google Earth imagery. The 2017 Google Earth imagery also suggests that additional vegetation was removed at the south end of the property, where the County culvert outlets onto lot 9, and the entire area of concern filled and re-landscaped.
