ROLLING MEADOWS ESTATES DRAINAGE STUDY

Governance & Priorities Committee

May 20, 2025

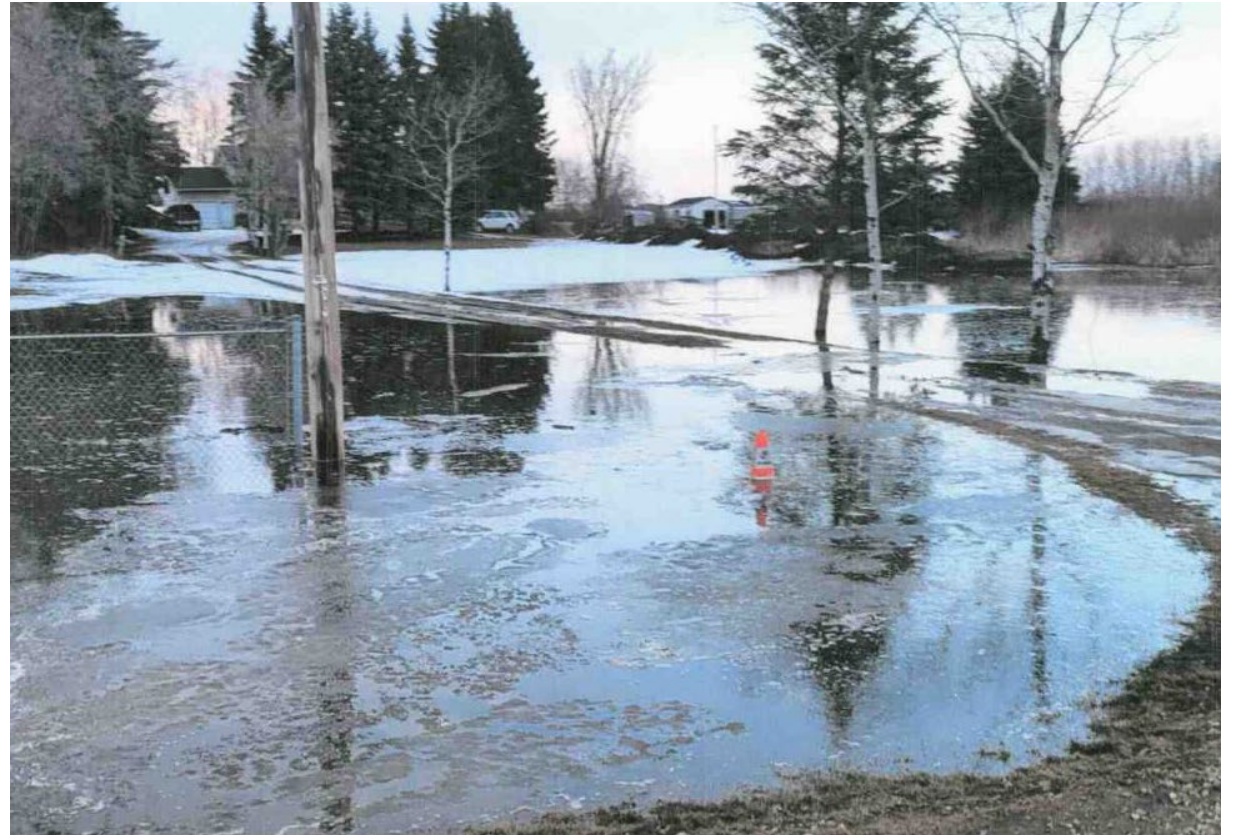
Reported Flooding Issues

- Reviewed historic flooding complaints from 2017 to 2022
 - Excessive runoff from south
 - Partially plugged culverts
 - Frozen culverts
 - Flooding of private lots

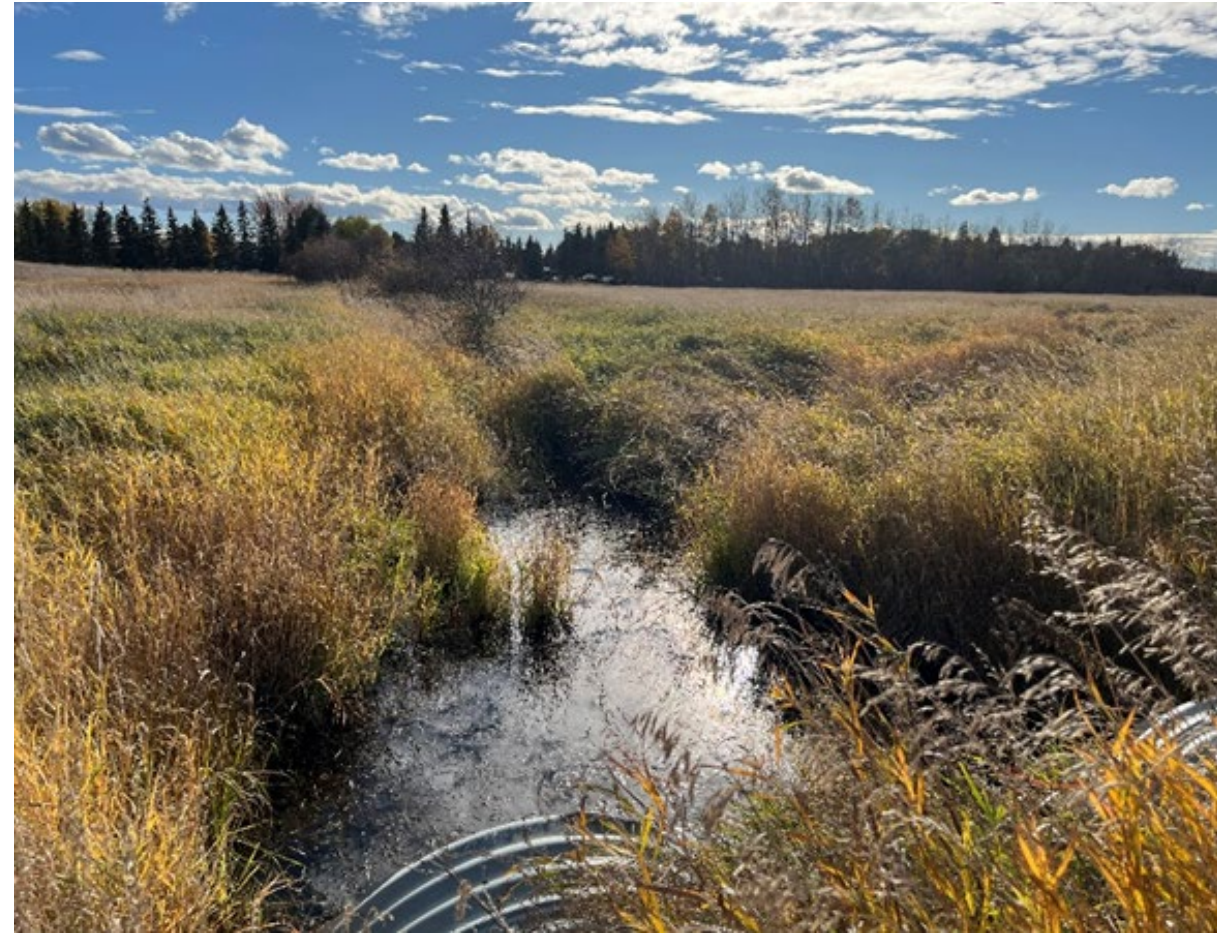
Hydraulic Analysis

- Atim Creek Tailwater Analysis
 - 1:100 year Big Lake High Water Level (HWL) 653.29 m
 - Estimated Atim Creek tailwater level
- Hydraulic Modeling
 - Farm crossing raises HWL by ~ 0.3 m
 - Large diameter culverts appear to be adequate
 - Off-site flows from southeast drain through Lot 12 uncontrolled
 - Off-site flows from southwest high for Lot 21 to 24 driveway culverts
 - Good correlation between modeling results and historic complaints

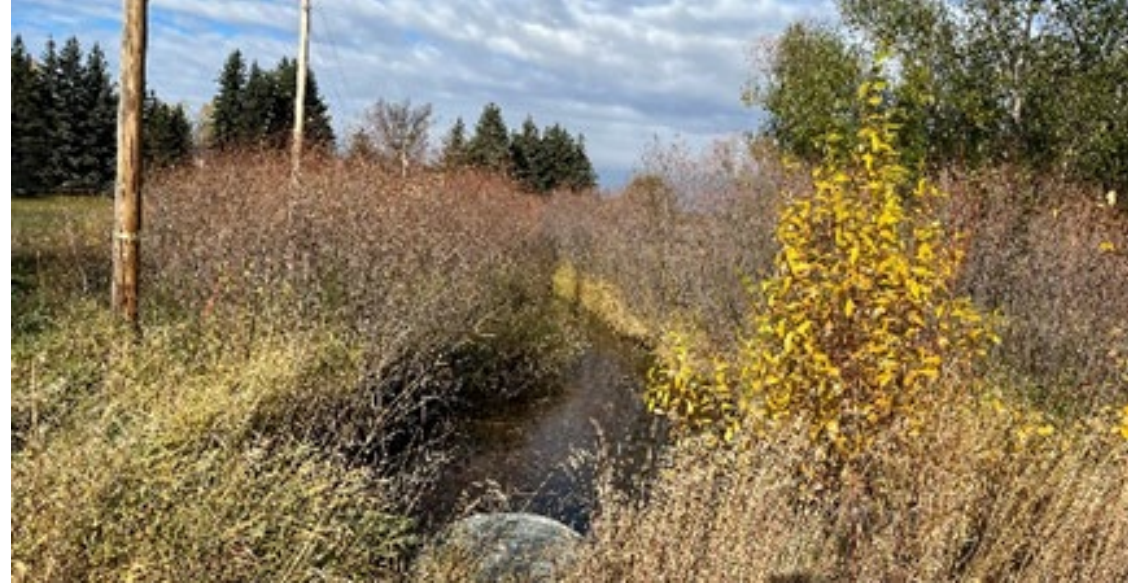
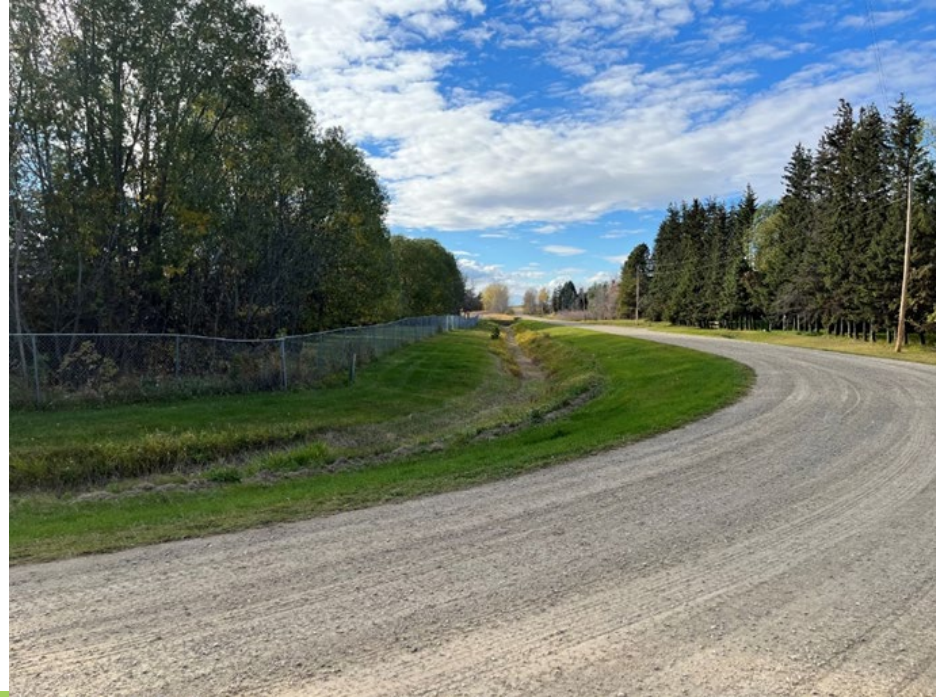
Factors influencing Flooding

- Elevation of Rolling Meadows relative to Atim Creek floodplain
- Location of Rolling Meadows within historic watercourses and wetlands
- Farm crossing
- High groundwater levels
- Local drainage system not designed for off-site flows
- Development of Spruce Grove

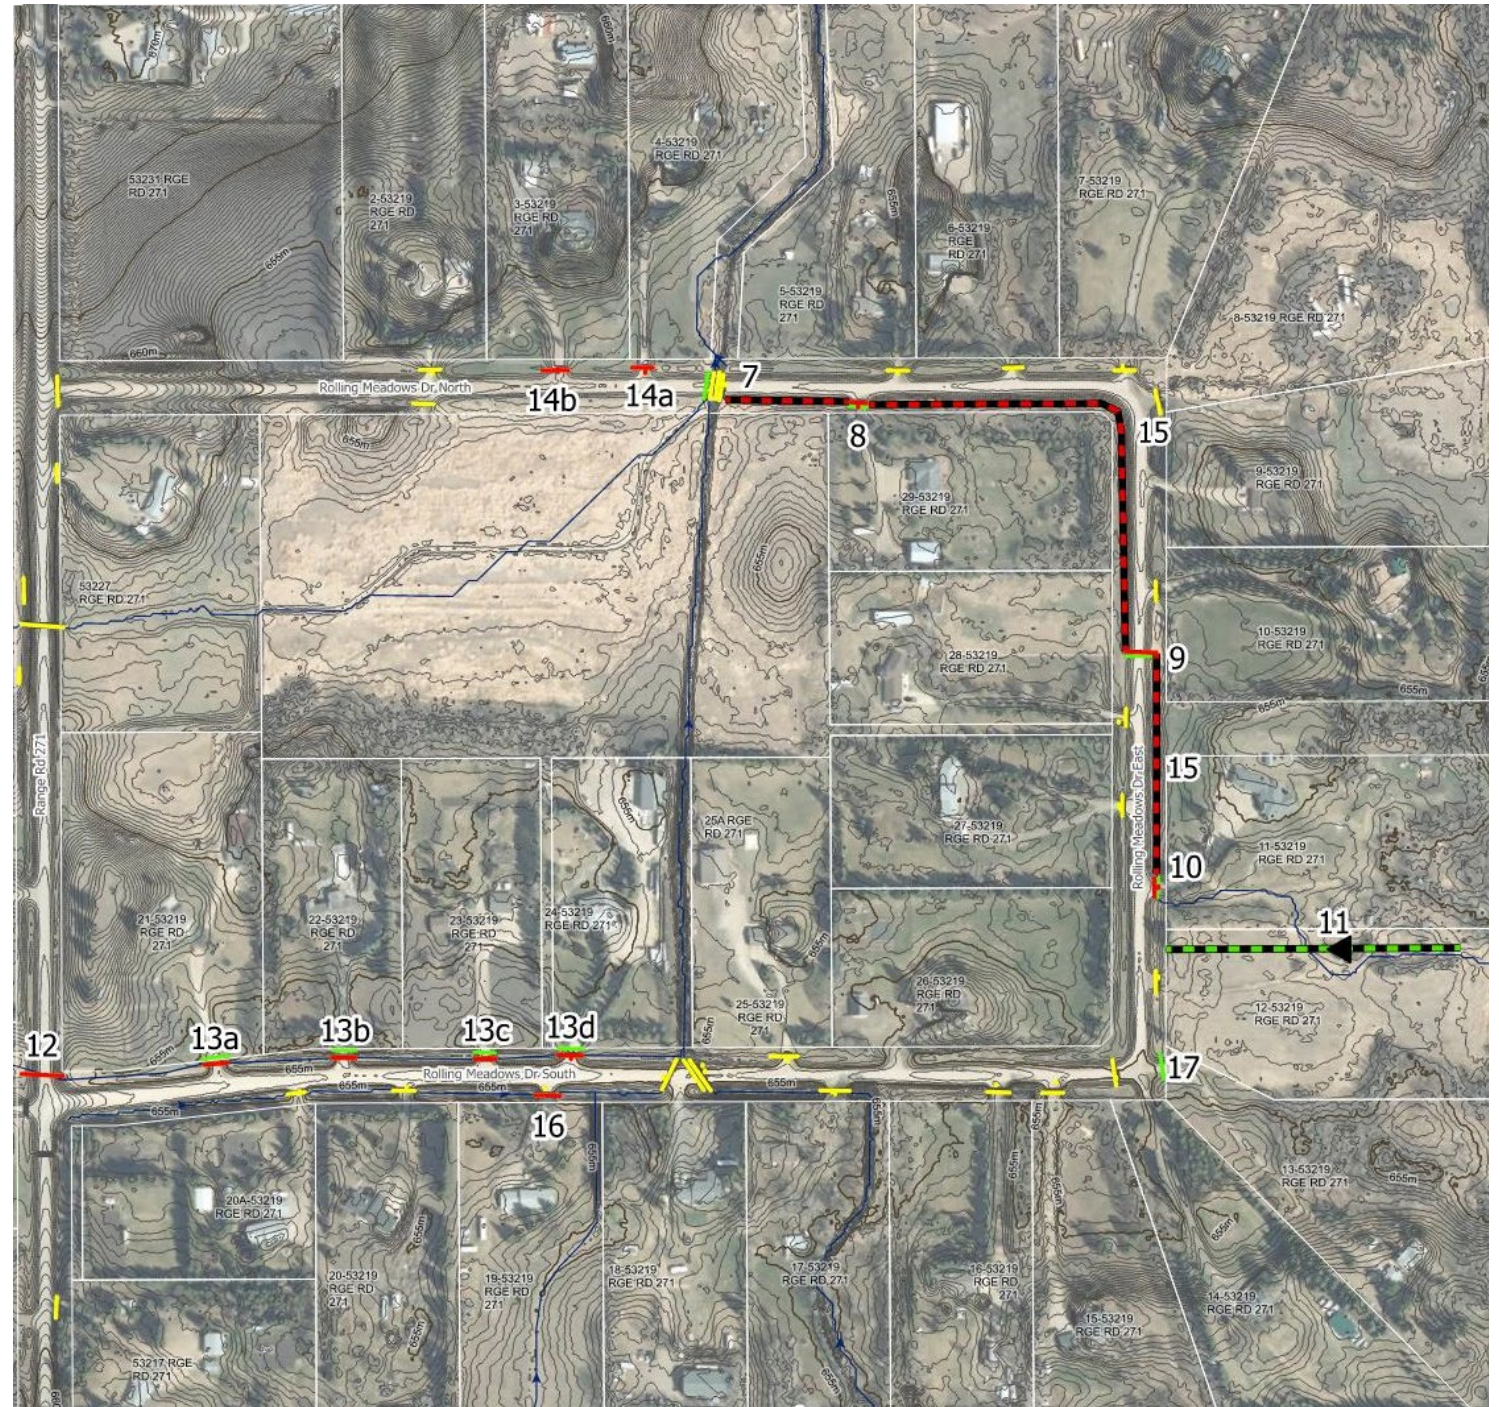
Flood Mitigation Options – On-site

- Culvert upgrades (#7-10, 13-14, 16-17)
- Ditch upgrades (#15)
- Swale (#11)

- Farm crossing
 - Remove farm crossing \$20,000
 - Upgrade farm crossing \$100,000 (order of magnitude)
- All on-site upgrading \$360,000
 - Culverts \$310,000
 - Ditch \$20,000
 - Swale \$30,000
- Total Cost \$380,000
 - (based on removal of farm crossing)
