# BIOPHYSICAL ASSESSMENT

## ALLAN BEACH RESORT

### PARKLAND COUNTY, ALBERTA

Bruce Thompson & Associates Inc.  
Edmonton, Alberta

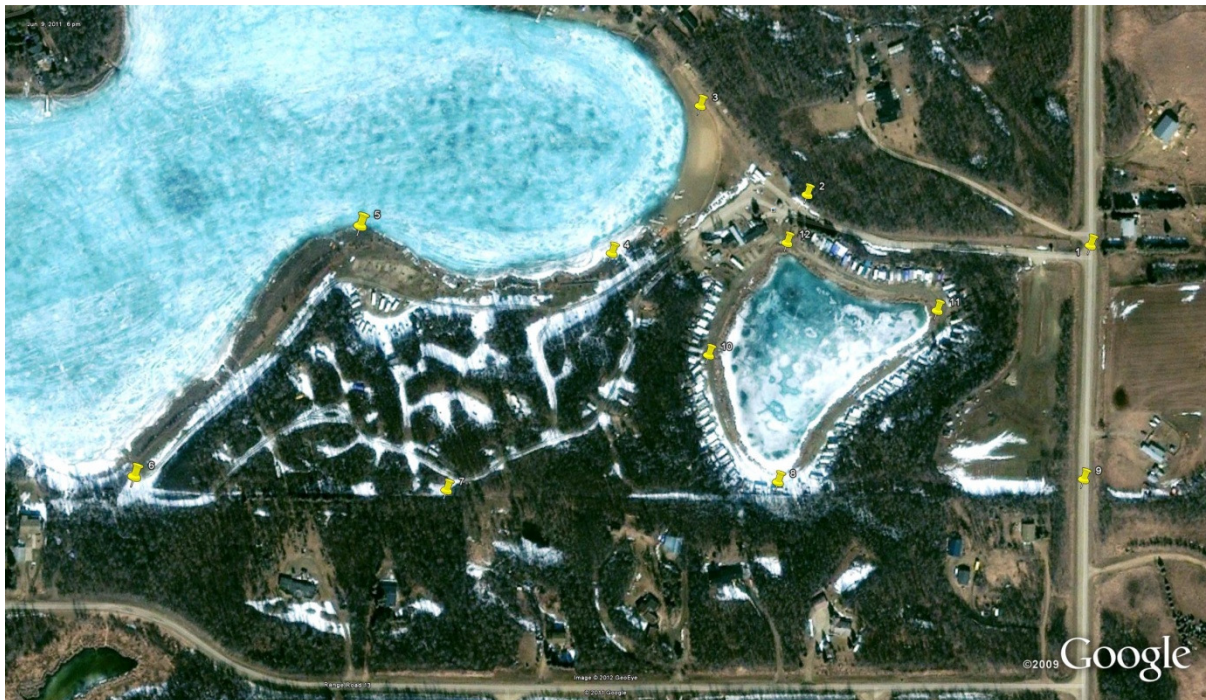
**Fig. 3:** Outline of the study area and the proposed development (yellow markers)(Google Earth Professional imagery).

Figs. 1-2 show the location of the project site in regional and local contexts. Figs. 3 and 4 show the boundaries of the proposed development site, and hence the study area for this Assessment.

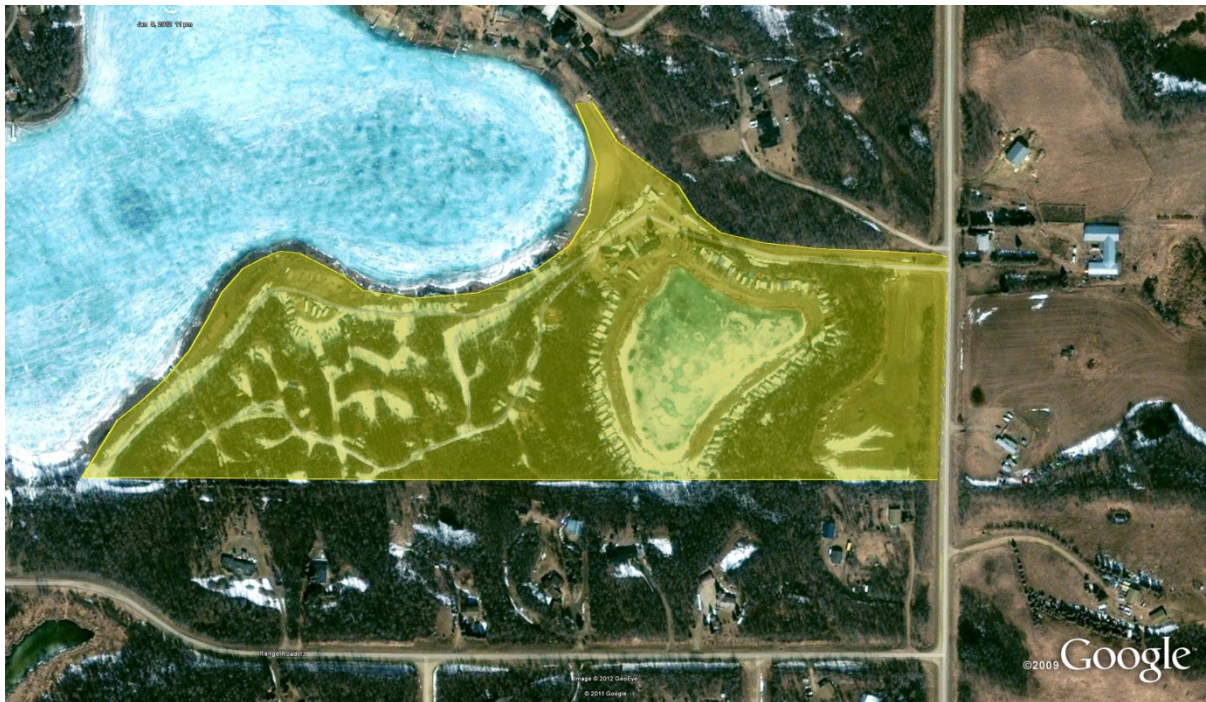
**Fig. 4:** Outline of the study area and the proposed development (yellow shading)(Google Earth Professional imagery).

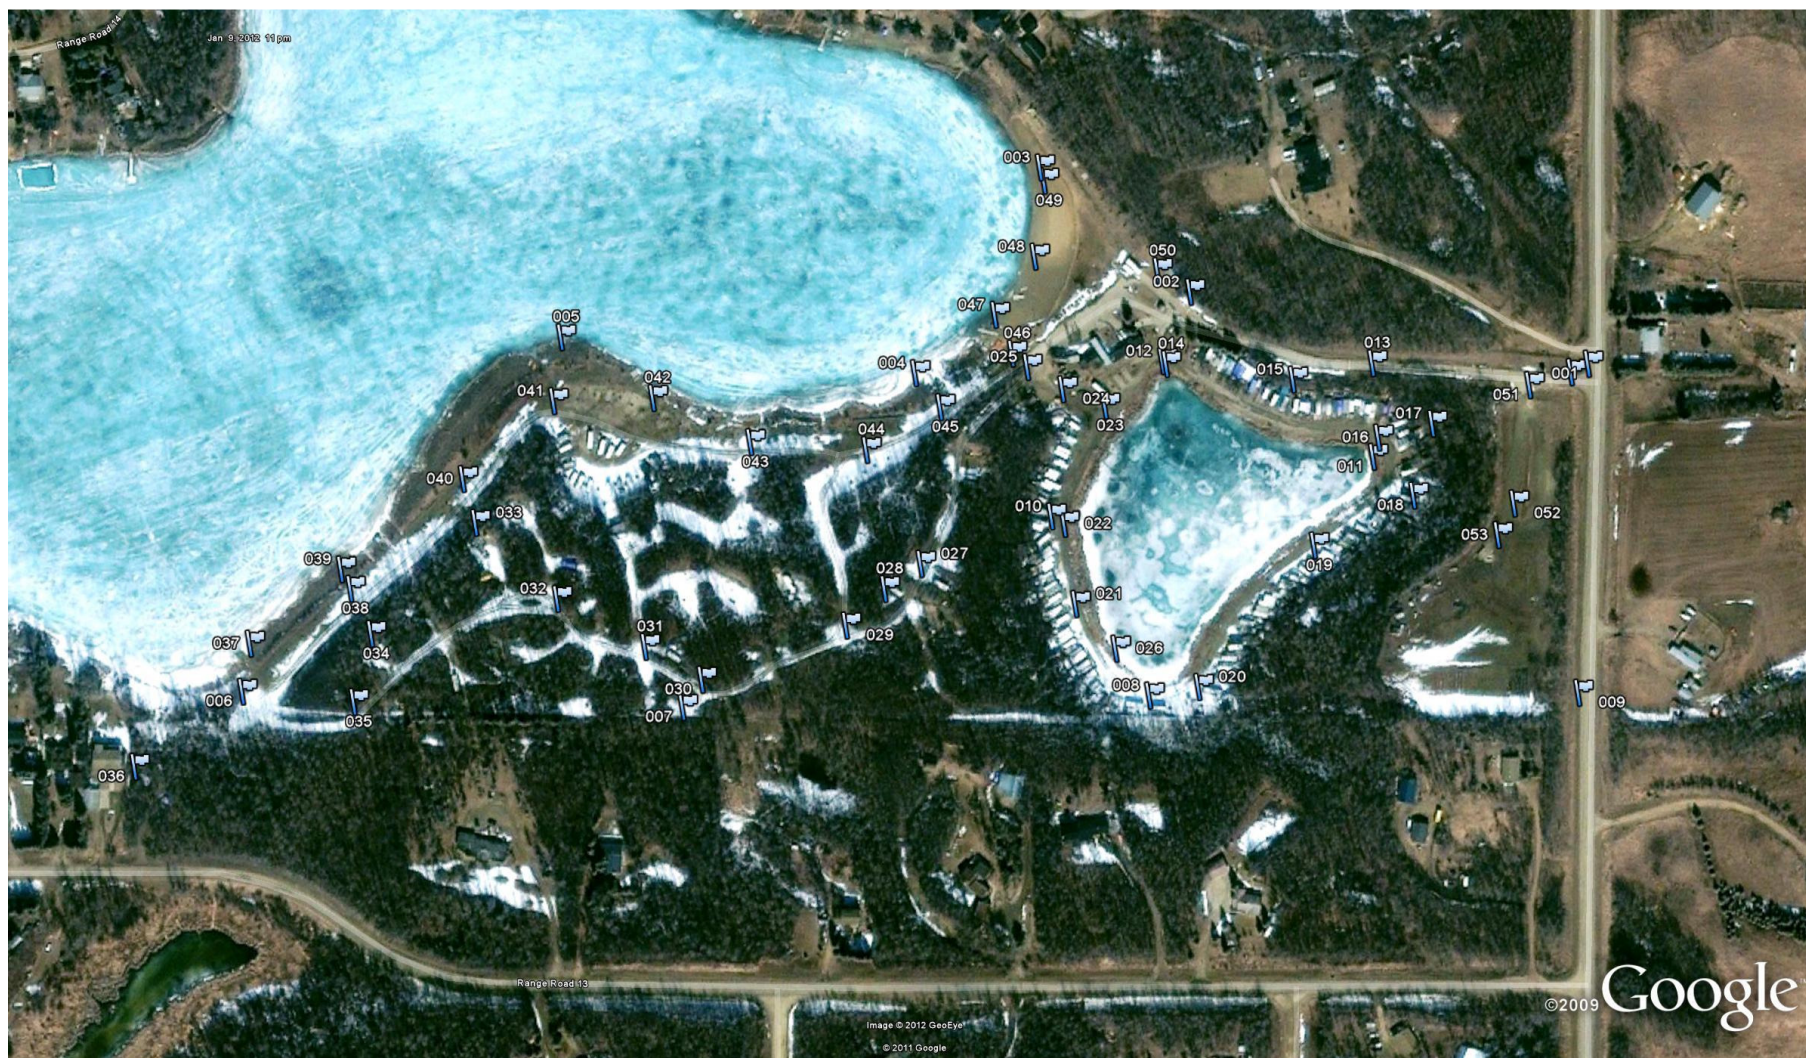
**Fig. 5:** Waypoints recorded during the field reconnaissance, January 9, 2012 (Google Earth Professional imagery).

Fig. 5 shows the GPS waypoints recorded at the site during the field reconnaissance in January, 2012.

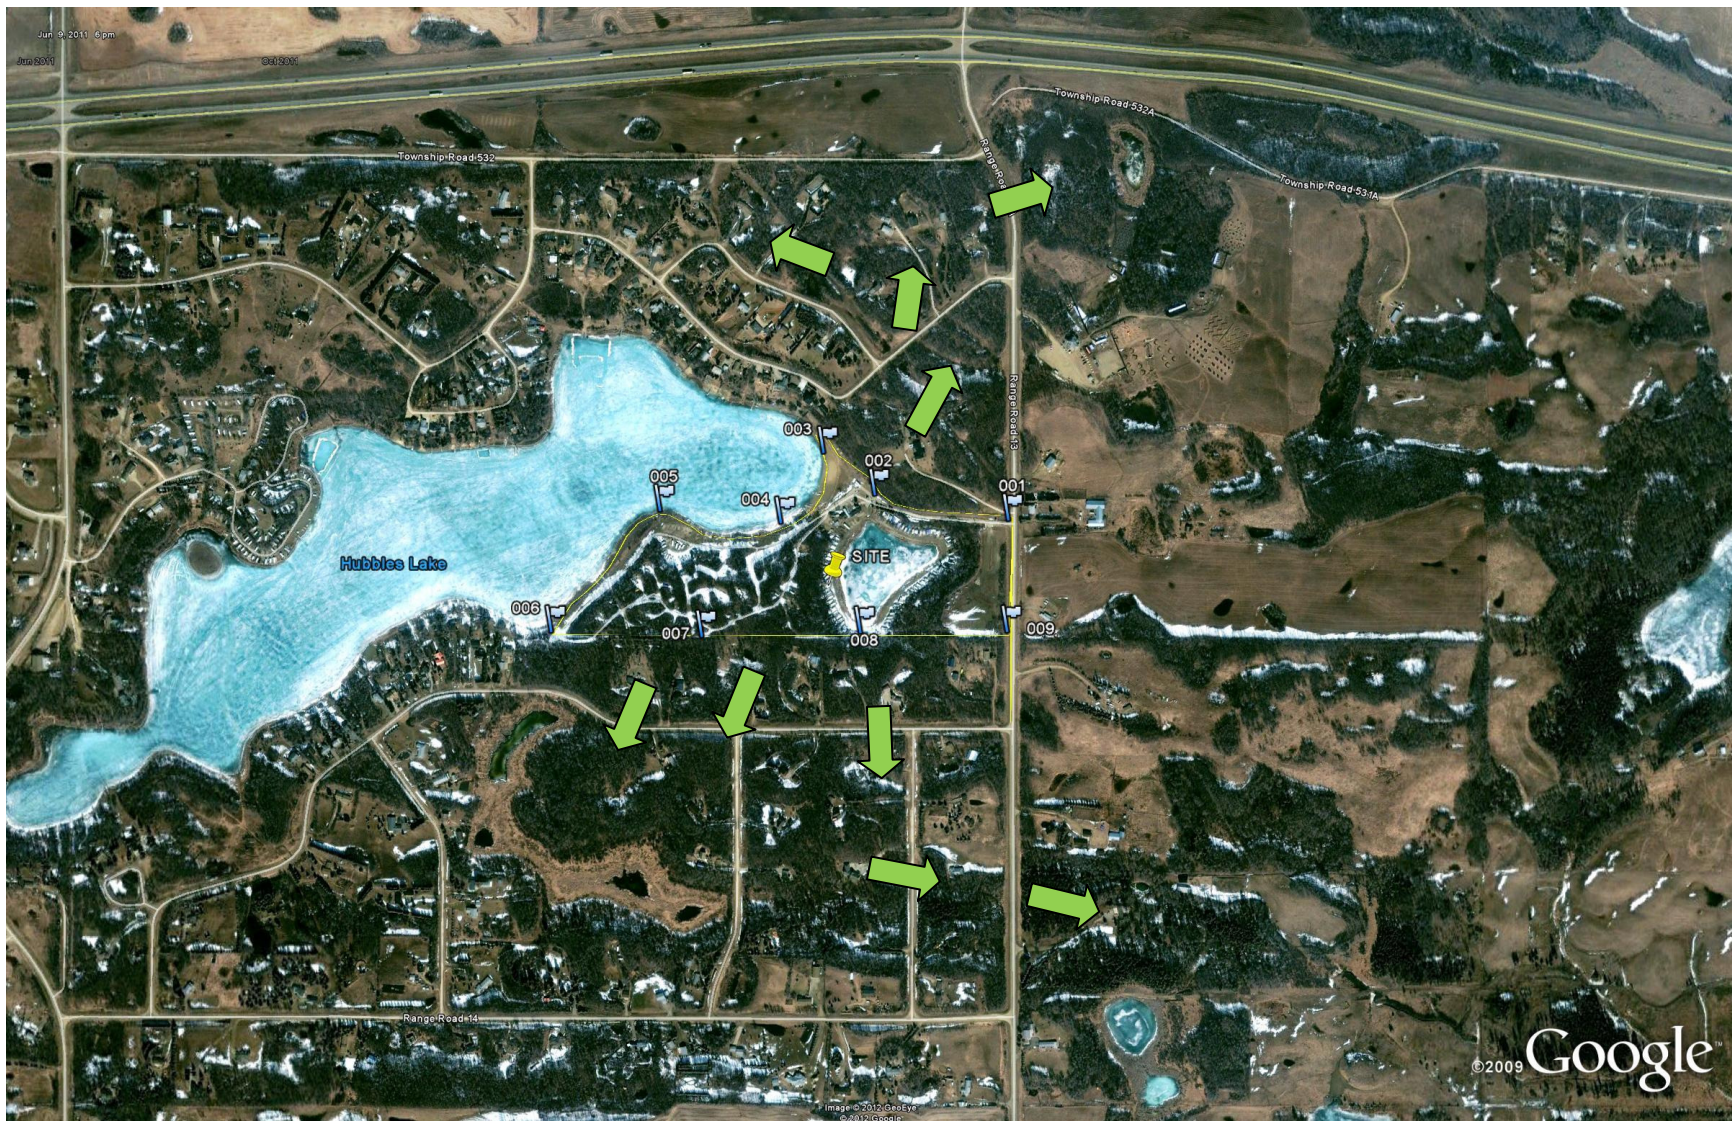
**Fig. 12:** Ecological linkages, medium range, based on wooded areas in the vicinity of the project site (imagery from Google Earth Pro, 2006). Green arrows indicate potentially "permeable" wooded corridors or stepping stone patches amongst core habitats (implies travel in both directions). Yellow marker indicates location of the study site.
