# TransAlta Tri Leisure Centre

Prepared for: TransAlta Tri Leisure Centre

Nordic Mechanical Services Ltd.

# EXECUTIVE SUMMARY

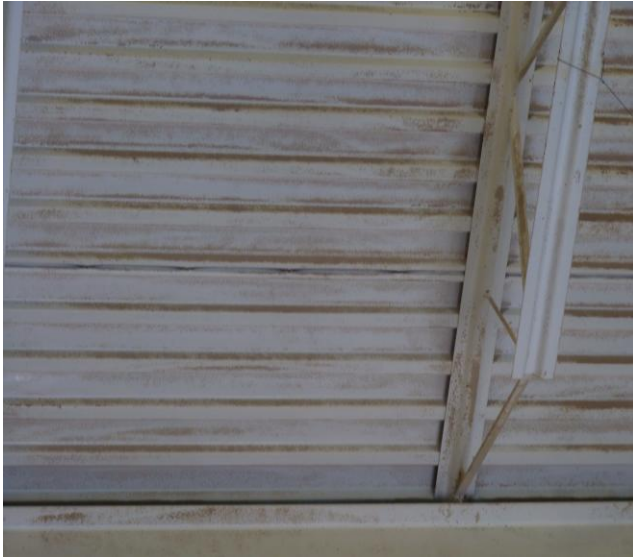
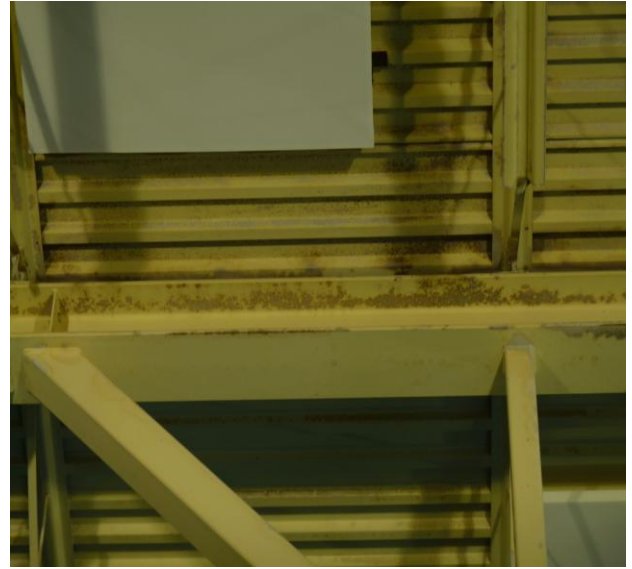
10. Paint on the roof deck and beams are discolored indicating corrosion is forming under the paint. A painting contractor should be consulted to look further into this issue.
