**Property Condition Assessment  
Update**

**Wabamun Arena**  
Wabamun, Alberta

Project No.: 116542032

August 18, 2016

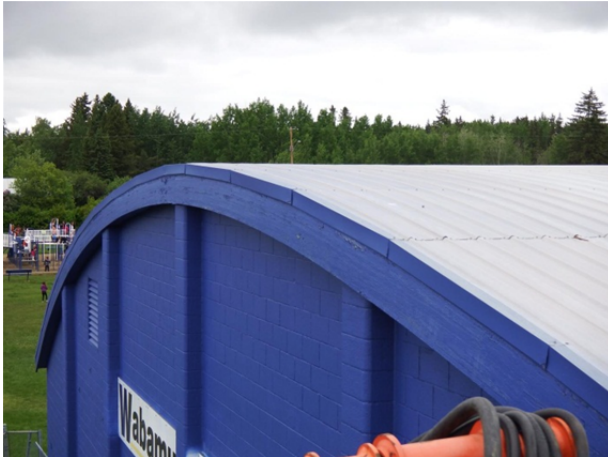
Arena's arch-frame roof at west end

| Event Year(s) | Event Description | Opinion of Probable Cost |
|---|---|---|
| 2017 | Allowance for replacement of the low slope roof system of the Arena. No allowance for the addition of insulation is included. | \$ 50,000 |

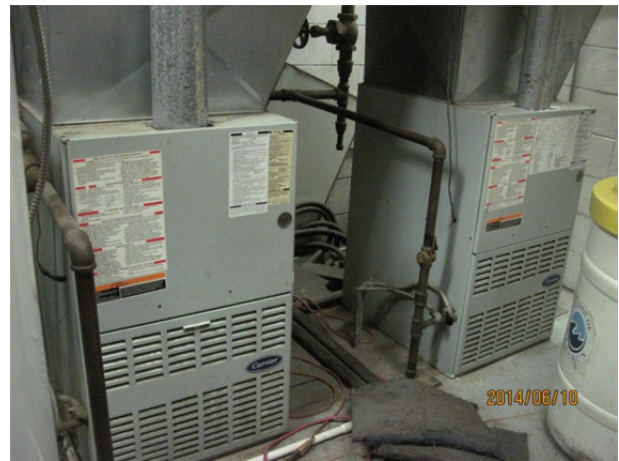
Arena furnaces

| Event Year | Event Description | Opinion of Probable Cost |
|---|---|---|
| 2022 | Allowance to replace the Arena furnaces | \$ 12,000 |

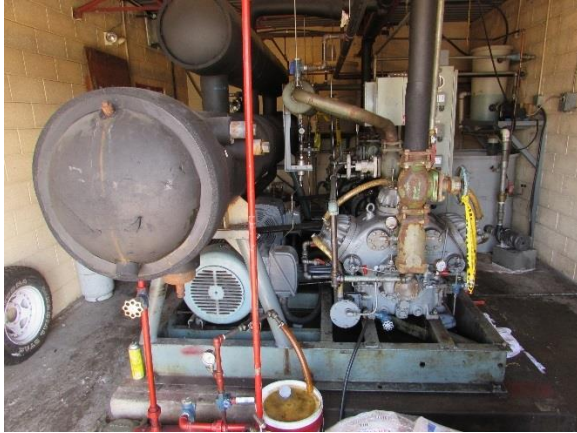
1. Skid mounted system

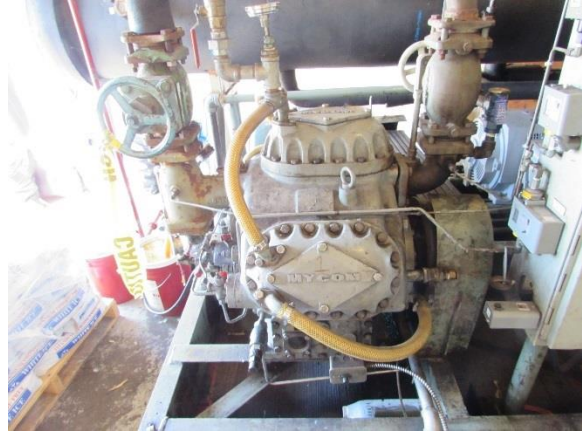
2. Original Mycom NW6A compressor

| Event Year | Event Description | Opinion of Probable Cost |
|---|---|---|
| 2016 & 2024 | Repair both Mycom N6A Compressors (Ice Plant) | \$ 24,000 |

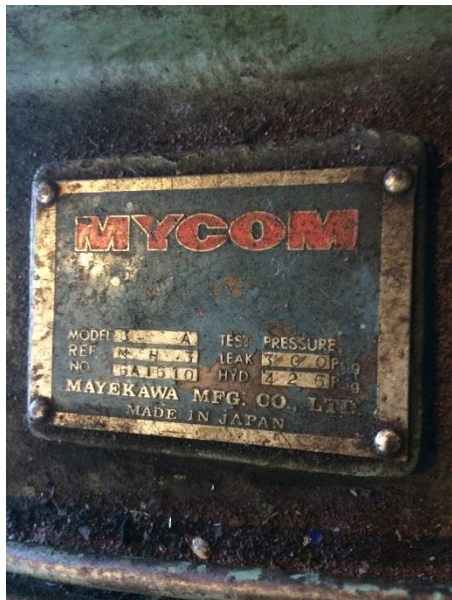
3. Mycom NW6A nameplate

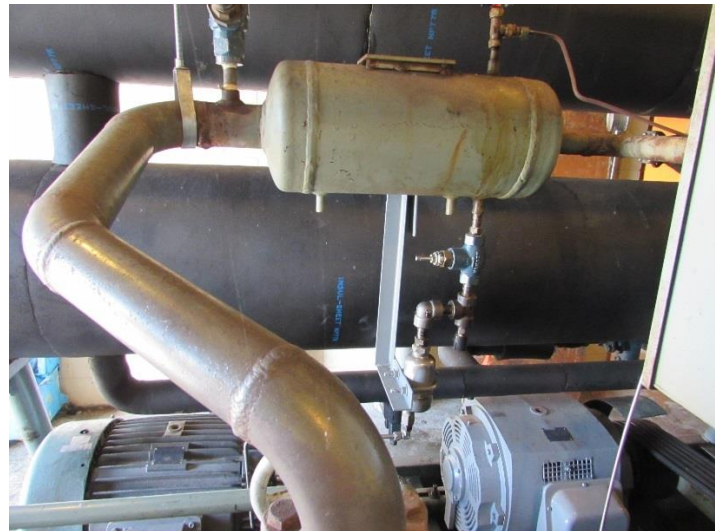
4. CIMCO oil separators with bracing to reduce vibration of liquid drainer.

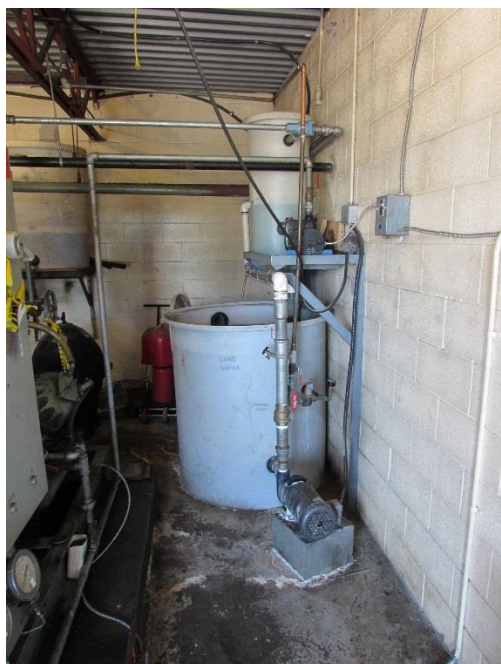
10. Condenser sump and pump.

| Event Year | Event Description | Opinion of Probable Cost |
|---|---|---|
| 2016 & 2026 | Repair or Replace Condenser sump/pump (Ice Plant) | \$ 6,000 |

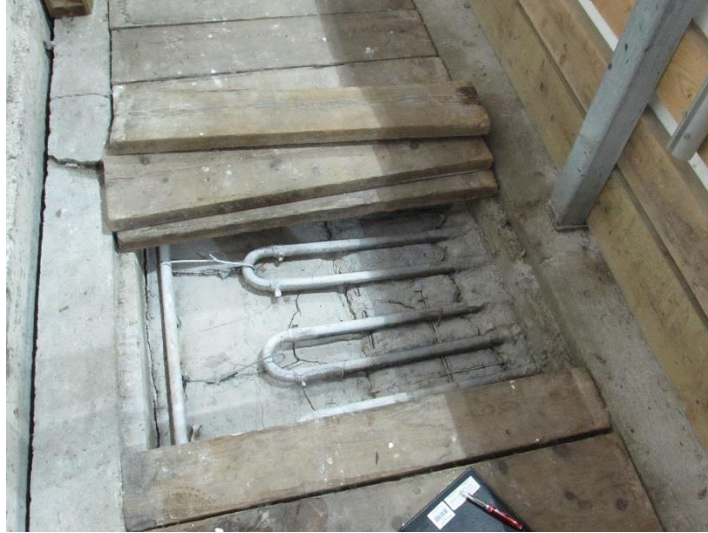
13. Return bend trench and floor piping.

| Event Year | Event Description | Opinion of Probable Cost |
|---|---|---|
| 2016 & periodically thereafter | Periodically clean, repaint or repair Brine mains, headers and floor piping (Ice Plant) | \$ 9,500 |

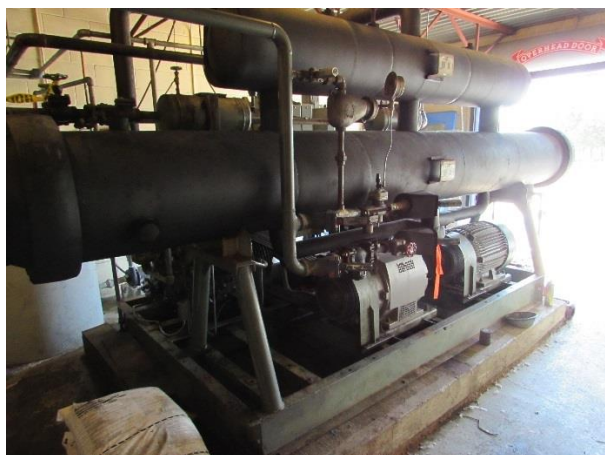
15. Docal chiller and surge drum.

| Event Year | Event Description | Opinion of Probable Cost |
|---|---|---|
| 2016 | Repair Chiller/surge drum (Ice Plant) | \$ 3,000 |

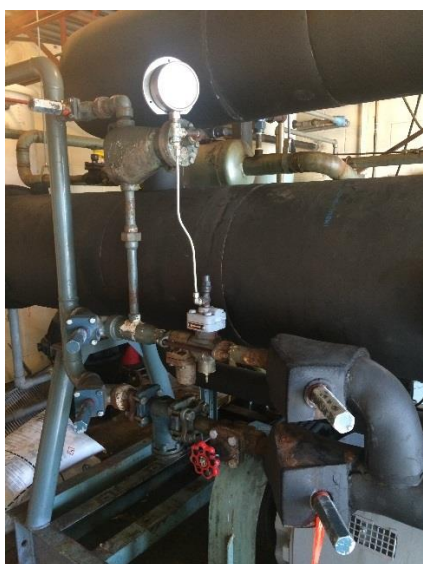
17. Chiller level controls and bypass.

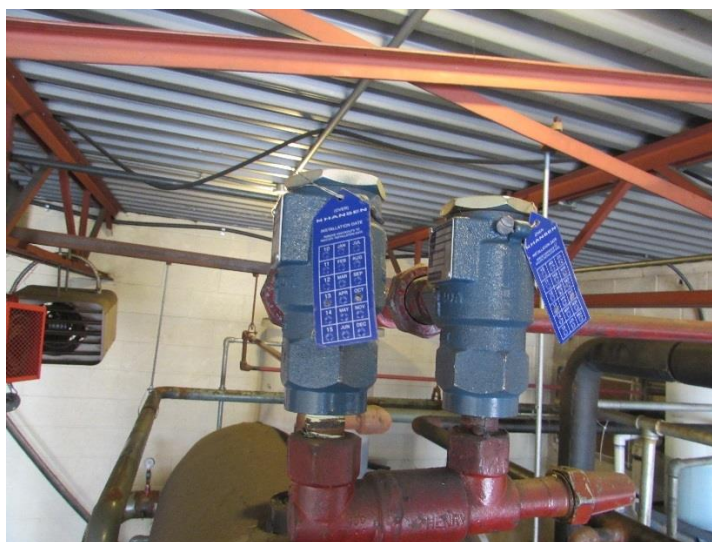
18. Relief valves with Oct. 2013 installation date.

| Event Year | Event Description | Opinion of Probable Cost |
|---|---|---|
| 2016 & periodically thereafter | Replace elements of the Relief Valve System (Ice Plant) | \$ 7,000 |
