PEMBINA RIVER: HIGH LEVEL BANK STABILITY REVIEW

PEMBINA RIVER VALLEY, ENTWISTLE, ALBERTA

JANUARY 9, 2018

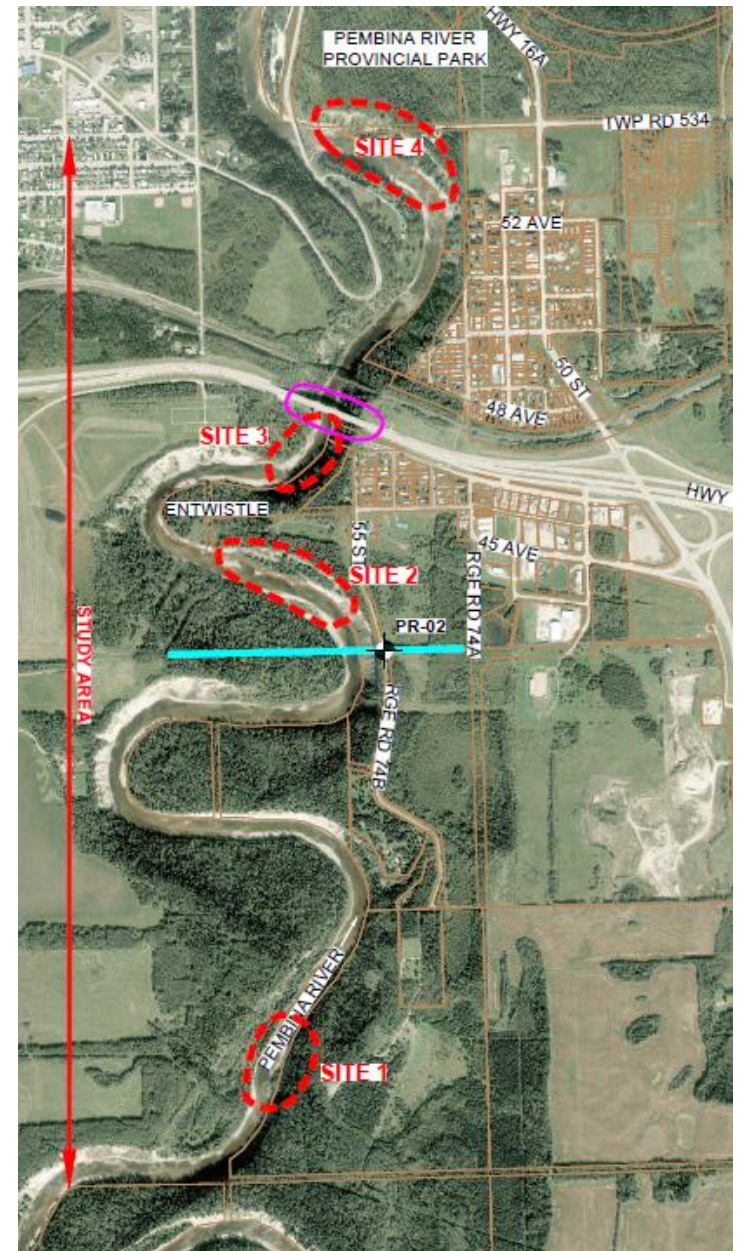
KEY FINDING 1

- Four historical landslides were identified through the desktop investigation. These locations were selected for site reconnaissance.
- None of the landslide locations appear to pose an imminent risk to existing development or infrastructure.

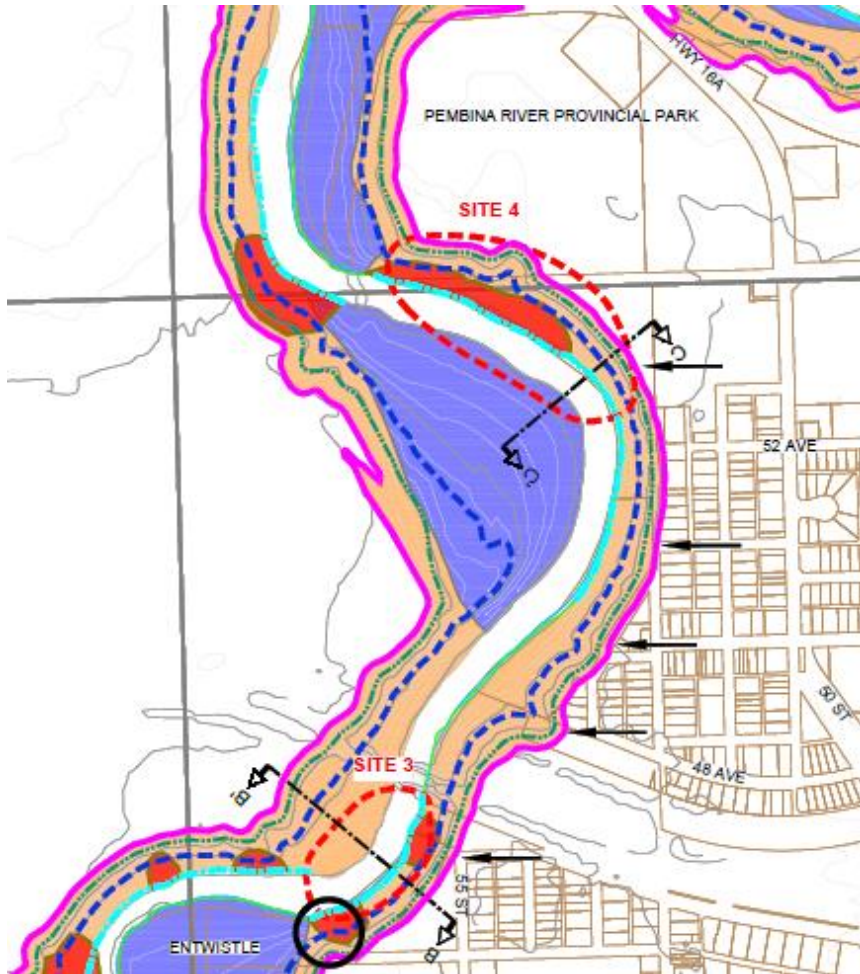
KEY FINDING 2

- There are five locations where concentrated overland flow is occurring over the Pembina River banks causing erosion.
- If left unabated, this erosion will continue during surface runoff events and over time will remove overburden soils down to exposed bedrock.
- It is not expected that that the erosion down to bedrock will cause overall instability to the valley slope. However, it is possible that the erosion of the overburden soils in these areas could progress eastward from the crest of the slope, destabilizing some of the near crest areas.

- Erosion control measures should be employed at the five locations where concentrated overland flow is occurring over the Pembina River banks.
- Repair could require regrading, armoring the crest and upper banks with rip-rap, erosion control blankets, or a similar engineered method.
